# Access Compliance Report

## Public Rights-of-Way

| Intersection ID: 47944 | Main Street: SHARON_VIEW_RD | Cross Street: PHILLIPS_GATE_DR | Location: NW |
| ADA ID: 734D81209089 | Ramp Type: BlendTrans2 | Initial Pass/Fail: Fail | Overall Compliance: No |

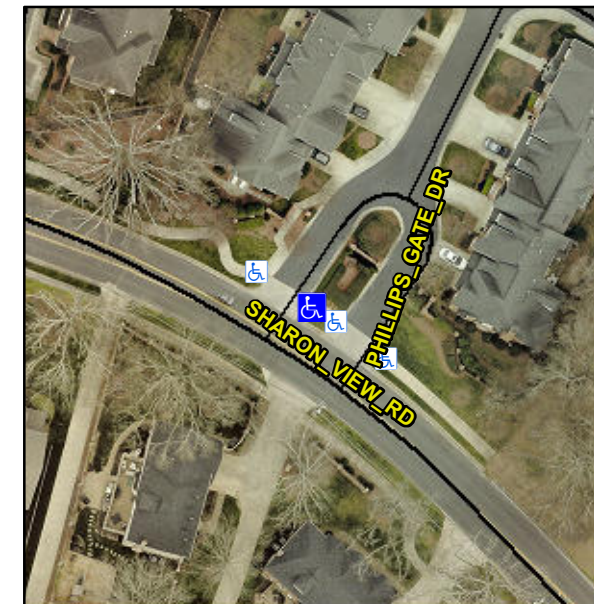
**NO CURB LINE**

**R304.5.3**

| Compliance | Description | Data | Compliance | Description | Data |
|---|---|---|---|---|---|
| Yes | Ramp Width (in) | 60.0 | No | BlendTrans XSlope (%) | 2.7 |

**Remove & Replace Curb Ramp With Two New Directional Ramps or Equivalent.**
