# Access Compliance Report

## Public Rights-of-Way

| Intersection ID: 32165 | Main Street: FOLIO CLUB DR | Cross Street: MARIE ROGET WY | Location: NW |
| ADA ID: 734EF5BFB233 | Ramp Type: BlendTrans1 | Initial Pass/Fail: Fail | Overall Compliance: No |

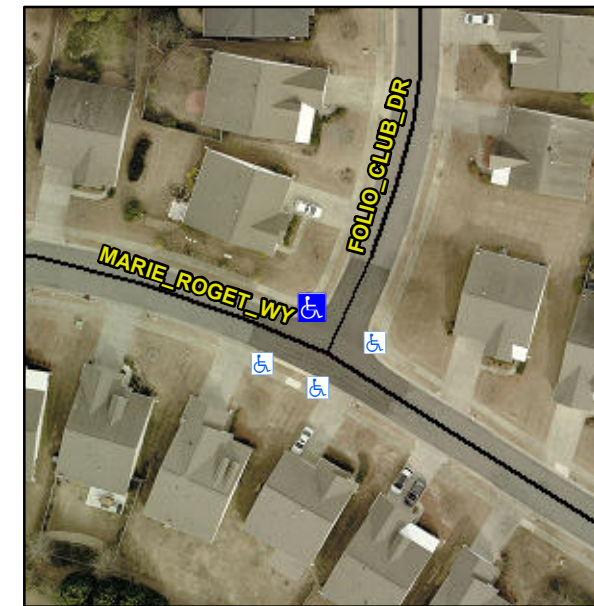
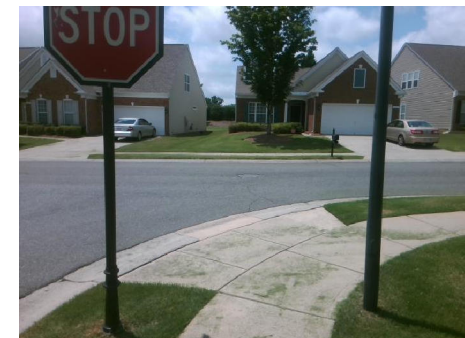
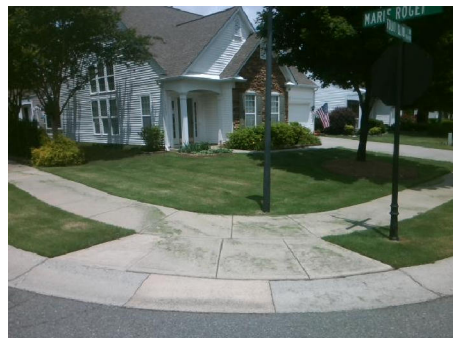
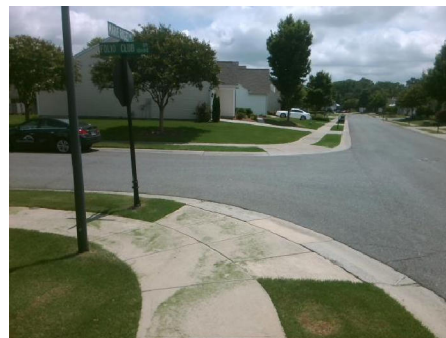
**CURB GAP 2.0**

**Not Found, R304.5.3**

| Compliance | Description | Data | Compliance | Description | Data |
|---|---|---|---|---|---|
| Yes | Ramp Width (in) | 66.0 | No | BlendTrans XSlope (%) | 5.3 |
| | | | No | Curb Slope (%) | 20.0 |

**Remove & Replace Curb Ramp With Two New Directional Ramps or Equivalent.**
