Access Compliance Report

Public Rights-of-Way

(Curb Ramps)

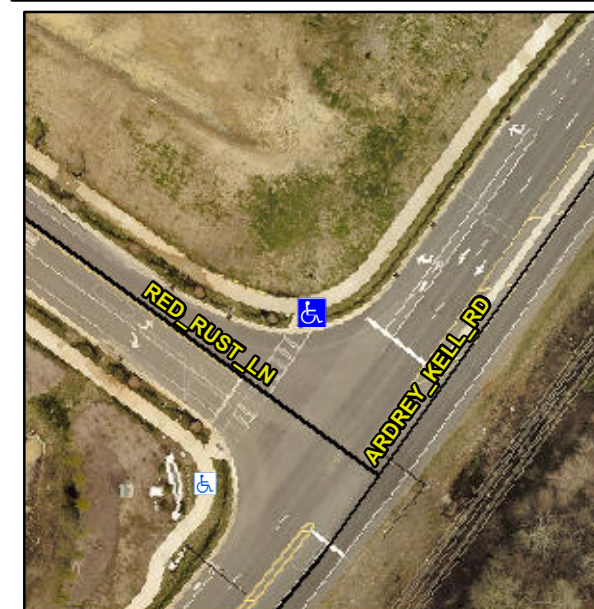
Intersection ID: 10035681	Main Street: RED_RUST_LN	Cross Street: N/A	Location:	N
ADA ID: 7357BCEC254E	Ramp Type: PerpDiag	Initial Pass/Fail: Fail	Overall Compliance: No	Severity Score: 12.5
Codes/Mitigation Info/Possible Solution		Field Measurements/Component Compliance

Not Found, R304.5.3

Compliance	Description	Data	Compliance	Description	Data
N/A	Ramp Length (in)	92.0	Yes	Ramp Slope (%)	5.3
Yes	Ramp Width (in)	59.5	No	Ramp XSlope (%)	6.8
N/A	Flare Type LT	N/A	N/A	Flare Type RT	N/A
N/A	Flare Slope LT (%)	N/A	N/A	Flare Slope RT (%)	N/A
N/A	Flare Traversable LT?	N/A	N/A	Flare Traversable RT?	N/A
N/A	Landing Length (in)	N/A	N/A	DWS Provided?	N/A
N/A	Landing Width (in)	N/A	N/A	DWS Contrast?	N/A
N/A	Landing Slope (%)	N/A	N/A	DWS Length (in)	N/A
N/A	Landing X Slope (%)	N/A	N/A	DWS Full Width?	N/A
N/A	Landing Curb? (Y/N)	N/A	N/A	DWS Offset (in)	N/A
N/A	Shared Landing?	N/A			
N/A	Gutter Ponding?	N/A	N/A	Gutter Slope (%)	N/A
N/A	Gutter Lip Ht (in)	N/A	N/A	Gutter X Slope (%)	N/A
N/A	Painted X Walk1?	No	N/A	Painted X Walk2?	No
	X Walk 1 Direction	To SW		X Walk 2 Direction	To SE
N/A	X Walk 1 Width (in)	N/A	N/A	X Walk 2 Width (in)	N/A
	X Walk 1 Slope (%)	1.1		X Walk 2 Slope (%)	4.3
	X Walk 1 X Slope (%)	4.3		X Walk 2 X Slope (%)	0.2

N/A	Ramp inside XWalk1?	N/A	N/A	Ramp inside XWalk2?	N/A
	Road Slope (%)	3.7	N/A	Clear Space?	N/A
	Road X Slope (%)	2.2	N/A	Clear Space to XWalk (in)	N/A
N/A	Any Obstructions?	N/A	N/A	Storm Grate/Utility Hazard?	N/A
	Obstruction Type			Storm Grate/Utility Type	
		N/A			N/A
		Yes		Surface Condition? (G/P)	Good

Remove & Replace Curb Ramp With Two New Directional Ramps or Equivalent.
