# Access Compliance Report

## Public Rights-of-Way

### (Curb Ramps)

Intersection ID: 53401	Main Street: VAWTER_DR	Cross Street: AGNEW_DR	Location: SW
ADA ID: 736A31A45183	Ramp Type: Perp	Initial Pass/Fail: Fail	Overall Compliance: No
Severity Score: 8.75			
Codes/Mitigation Info/Possible Solution		Field Measurements/Component Compliance

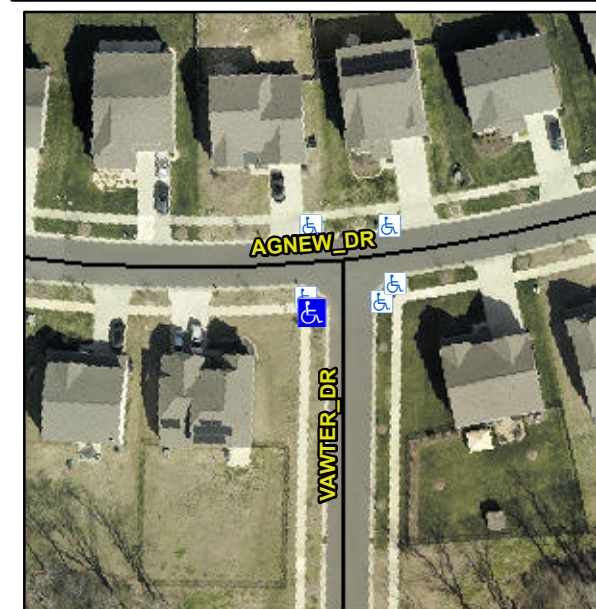
**Not Found, R304.5.1**

Compliance	Description	Data	Compliance	Description	Data
N/A	Ramp Length (in)	101.0	Yes	Ramp Slope (%)	5.3
No	Ramp Width (in)	46.5	Yes	Ramp XSlope (%)	0.4
N/A	Flare Type LT	N/A	N/A	Flare Type RT	N/A
N/A	Flare Slope LT (%)	N/A	N/A	Flare Slope RT (%)	N/A
N/A	Flare Traversable LT?	N/A	N/A	Flare Traversable RT?	N/A
N/A	Landing Length (in)	N/A	N/A	DWS Provided?	N/A
N/A	Landing Width (in)	N/A	N/A	DWS Contrast?	N/A
N/A	Landing Slope (%)	N/A	N/A	DWS Length (in)	N/A
N/A	Landing X Slope (%)	N/A	N/A	DWS Full Width?	N/A
N/A	Landing Curb? (Y/N)	N/A	N/A	DWS Offset (in)	N/A
N/A	Shared Landing?	N/A			
N/A	Gutter Ponding?	N/A	N/A	Gutter Slope (%)	N/A
N/A	Gutter Lip Ht (in)	N/A	N/A	Gutter X Slope (%)	N/A
N/A	Painted X Walk1?	No	N/A	Painted X Walk2?	N/A
	X Walk 1 Direction	To E		X Walk 2 Direction	N/A
N/A	X Walk 1 Width (in)	N/A	N/A	X Walk 2 Width (in)	N/A
	X Walk 1 Slope (%)	3.0		X Walk 2 Slope (%)	N/A
	X Walk 1 X Slope (%)	0.7		X Walk 2 X Slope (%)	N/A

N/A	Ramp inside XWalk1?	N/A	N/A	Ramp inside XWalk2?	N/A
	Road Slope (%)	N/A	N/A	Clear Space?	N/A
	Road X Slope (%)	N/A	N/A	Clear Space to XWalk (in)	N/A
N/A	Any Obstructions?	N/A	N/A	Storm Grate/Utility Hazard?	N/A
	Obstruction Type			Storm Grate/Utility Type	
		N/A			N/A
			Yes	Surface Condition? (G/P)	Good

**Remove & Replace Entire Ramp.**

Total Cost: \$ 1850.00
