# Access Compliance Report

## Public Rights-of-Way

### (Curb Ramps)

| Intersection ID: 29125 | Main Street: ALDERPOINT_LN | Cross Street: APPLIEDALE_DR | Location: S |

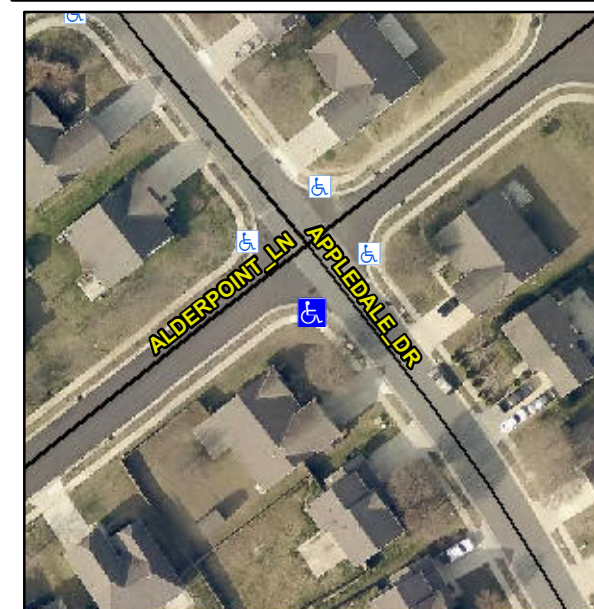
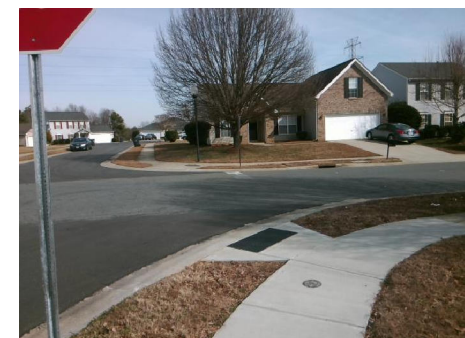
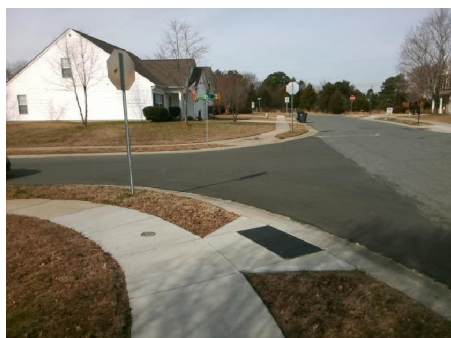
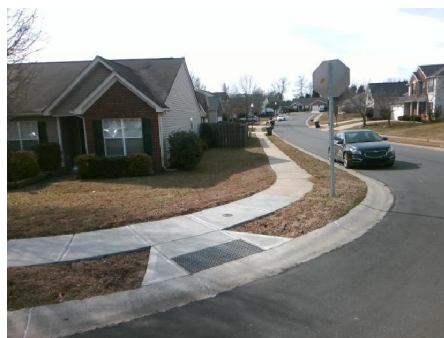
| ADA ID: 736F1E3DDC35 | Ramp Type: BlendTrans1 | Initial Pass/Fail: Fail | Overall Compliance: No |

**Not Found, R304.5.1**

| Compliance | Description | Data | Compliance | Description | Data |
|---|---|---|---|---|---|
| No | Ramp Width (in) | 46.0 | Yes | BlendTrans XSlope (%) | 0.2 |
| | | | No | Curb Slope (%) | 10.4 |

**Remove & Replace Curb Ramp With Two New Directional Ramps or Equivalent.**

Total Cost: \$ 3200.00
