# Access Compliance Report

## Public Rights-of-Way

### (Curb Ramps)

Intersection ID: 42554	Main Street: ENEIDA_SUE_DR	Cross Street: TODDVILLE_RD	Location: S
ADA ID: 73708BCC2E03	Ramp Type: Perp	Initial Pass/Fail: Fail	Overall Compliance: No
Severity Score: 12.5			
Codes/Mitigation Info/Possible Solution		Field Measurements/Component Compliance

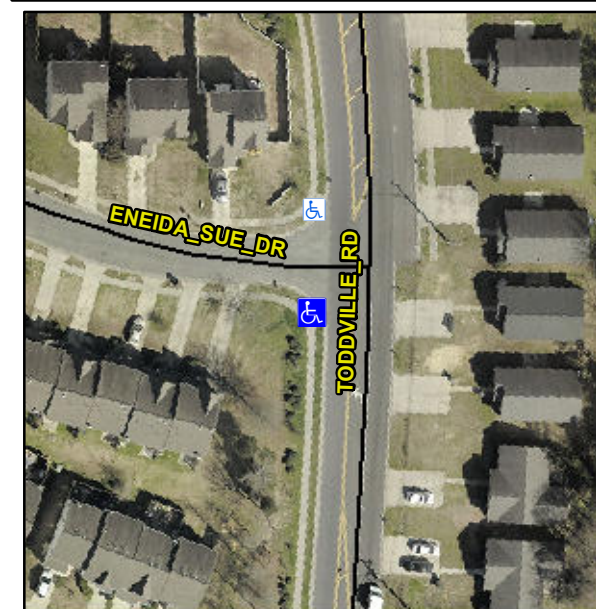
**Not Found, R304.2.2**

Compliance	Description	Data	Compliance	Description	Data
N/A	Ramp Length (in)	48.5	No	Ramp Slope (%)	8.7
Yes	Ramp Width (in)	49.5	Yes	Ramp XSlope (%)	1.4
N/A	Flare Type LT	N/A	N/A	Flare Type RT	N/A
N/A	Flare Slope LT (%)	N/A	N/A	Flare Slope RT (%)	N/A
N/A	Flare Traversable LT?	N/A	N/A	Flare Traversable RT?	N/A
N/A	Landing Length (in)	N/A	N/A	DWS Provided?	N/A
N/A	Landing Width (in)	N/A	N/A	DWS Contrast?	N/A
N/A	Landing Slope (%)	N/A	N/A	DWS Length (in)	N/A
N/A	Landing X Slope (%)	N/A	N/A	DWS Full Width?	N/A
N/A	Landing Curb? (Y/N)	N/A	N/A	DWS Offset (in)	N/A
N/A	Shared Landing?	N/A			
N/A	Gutter Ponding?	N/A	N/A	Gutter Slope (%)	N/A
N/A	Gutter Lip Ht (in)	0.5	N/A	Gutter X Slope (%)	N/A
N/A	Painted X Walk1?	No	N/A	Painted X Walk2?	N/A
	X Walk 1 Direction	To N		X Walk 2 Direction	N/A
N/A	X Walk 1 Width (in)	N/A	N/A	X Walk 2 Width (in)	N/A
	X Walk 1 Slope (%)	0.2		X Walk 2 Slope (%)	N/A
	X Walk 1 X Slope (%)	3.9		X Walk 2 X Slope (%)	N/A

N/A	Ramp inside XWalk1?	N/A	N/A	Ramp inside XWalk2?	N/A
	Road Slope (%)	N/A	N/A	Clear Space?	N/A
	Road X Slope (%)	N/A	N/A	Clear Space to XWalk (in)	N/A
N/A	Any Obstructions?	N/A	N/A	Storm Grate/Utility Hazard?	N/A
	Obstruction Type			Storm Grate/Utility Type	
		N/A			N/A
			Yes	Surface Condition? (G/P)	Good

**Remove & Replace Entire Ramp.**
