## **Access Compliance Report Public Rights-of-Way** (Curb Ramps)

Intersection ID: 50522 Main Street: JASMIN MAY DR **Cross Street: REA FOREST DR** Location: SW **Overall Compliance: No** ADA ID: 73797537C727 Ramp Type: PerpDiag Initial Pass/Fail: Fail Severity Score: 21.25

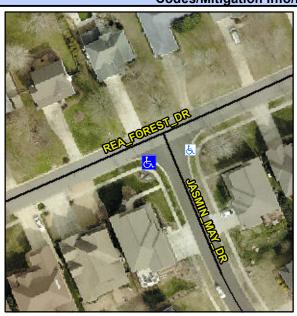
Yes N/A Ramp Length (in) 72.0 Ramp Slope (%) 6.9 No Ramp XSlope (%) No Ramp Width (in) 47.0 5.4 N/A N/A Flare Type LT N/A Flare Type RT N/A N/A Flare Slope LT (%) N/A N/A Flare Slope RT (%) N/A N/A Flare Traversable LT? N/A N/A Flare Traversable RT? N/A N/A Landing Length (in) N/A N/A **DWS Provided?** N/A N/A Landing Width (in) N/A N/A **DWS Contrast?** N/A N/A N/A N/A Landing Slope (%) DWS Length (in) N/A N/A Landing X Slope (%) N/A N/A DWS Full Width? N/A N/A Landing Curb? (Y/N) N/A N/A DWS Offset (in) N/A N/A N/A Shared Landing? N/A **Gutter Ponding?** N/A N/A Gutter Slope (%) N/A N/A Gutter Lip Ht (in) N/A N/A Gutter X Slope (%) N/A N/A Painted X Walk1? No N/A Painted X Walk2? No X Walk 1 Direction To NE X Walk 2 Direction To NW N/A N/A N/A X Walk 1 Width (in) X Walk 2 Width (in) N/A X Walk 1 Slope (%) 1.2 X Walk 2 Slope (%) 1.0 X Walk 1 X Slope (%) 3.7 X Walk 2 X Slope (%) 2.1 N/A N/A N/A Ramp inside XWalk2? N/A Ramp inside XWalk1? Road Slope (%) 3.9 N/A Clear Space? N/A N/A Road X Slope (%) 0.8 Clear Space to XWalk (in) N/A N/A N/A N/A Any Obstructions? Storm Grate/Utility Hazard? N/A **Obstruction Type** Storm Grate/Utility Type N/A

JASMIN MAY DR StopSign **REA FOREST DR** None Remove & Replace Curb Ramp With Two New Directional Ramps or Equivalent.

Not Found, R304.5.1, R304.5.3

Total Cost:		\$	3200.00
