Access Compliance Report

Public Rights-of-Way

(Curb Ramps)

Intersection ID: 13959	Main Street: CLEVELAND_AV	Cross Street: E_PARK_AV	Location: N
ADA ID: 737A7413BF90	Ramp Type: BlendTrans1	Initial Pass/Fail: Fail	Overall Compliance: No
Severity Score: 12.5			
Codes/Mitigation Info/Possible Solution		Field Measurements/Component Compliance

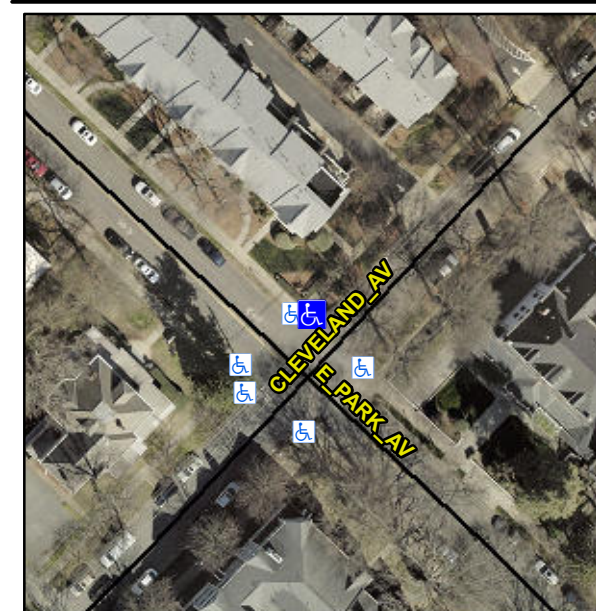
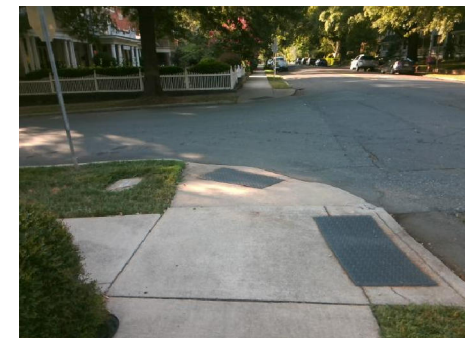
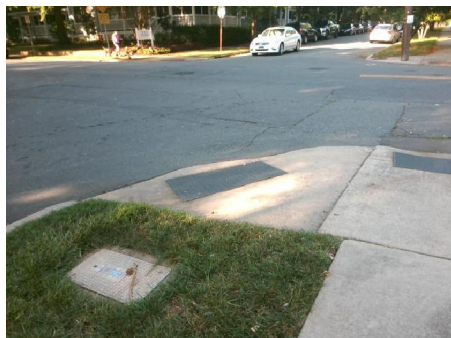
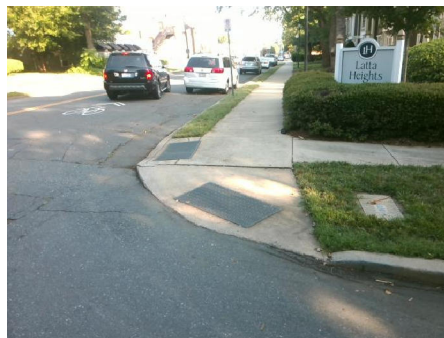
NO CURB LINE

Compliance	Description	Data	Compliance	Description	Data
N/A	Ramp Length (in)	31.0	Yes	BlendTrans Slope (%)	3.2
Yes	Ramp Width (in)	48.0	No	BlendTrans XSlope (%)	5.1
N/A	Flare Type LT	N/A	N/A	Flare Type RT	N/A
N/A	Flare Slope LT (%)	N/A	N/A	Flare Slope RT (%)	N/A
N/A	Flare Traversable LT?	N/A	N/A	Flare Traversable RT?	N/A
N/A	Landing Length (in)	N/A	N/A	DWS Provided?	N/A
N/A	Landing Width (in)	N/A	N/A	DWS Contrast?	N/A
N/A	Landing Slope (%)	N/A	N/A	DWS Length (in)	N/A
N/A	Landing X Slope (%)	N/A	N/A	DWS Full Width?	N/A
N/A	Landing Curb? (Y/N)	N/A	N/A	DWS Offset (in)	N/A
N/A	Shared Landing?	N/A			
N/A	Gutter Ponding?	N/A	N/A	Gutter Slope (%)	N/A
N/A	Gutter Lip Ht (in)	N/A	N/A	Gutter X Slope (%)	N/A
N/A	Painted X Walk1?	No	N/A	Painted X Walk2?	N/A
	X Walk 1 Direction	To SE		X Walk 2 Direction	N/A
	X Walk 1 Width (in)	N/A		X Walk 2 Width (in)	N/A
	X Walk 1 Slope (%)	3.3		X Walk 2 Slope (%)	N/A
	X Walk 1 X Slope (%)	4.3		X Walk 2 X Slope (%)	N/A

N/A	Ramp inside XWalk1?	N/A	N/A	Ramp inside XWalk2?	N/A
	Road Slope (%)	4.3		Clear Space?	N/A
	Road X Slope (%)	3.3	N/A	Clear Space to XWalk (in)	N/A
N/A	Any Obstructions?	N/A	N/A	Storm Grate/Utility Hazard?	N/A
	Obstruction Type			Storm Grate/Utility Type	
		N/A			N/A
			N/A	Surface Condition? (G/P)	N/A
			N/A	Curb Slope (%)	0.7

Possible Solutions:

Remove & Replace Curb Ramp With Two New Directional Ramps or Equivalent.

R304.5.3
