Access Compliance Report

Public Rights-of-Way

(Curb Ramps)

Intersection ID: 23386	Main Street: ALEXANDER_RD	Cross Street: BENNING_WOOD_DR	Location: SW
ADA ID: 737C1F329291	Ramp Type: Directional1	Initial Pass/Fail: Fail	Overall Compliance: No
		Severity Score: 1.25

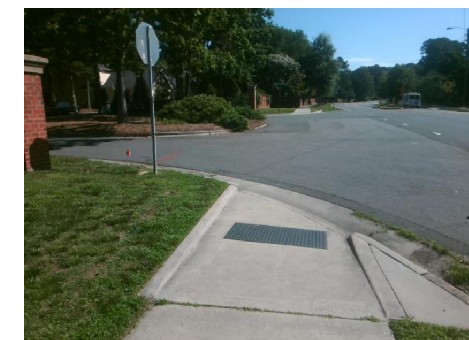
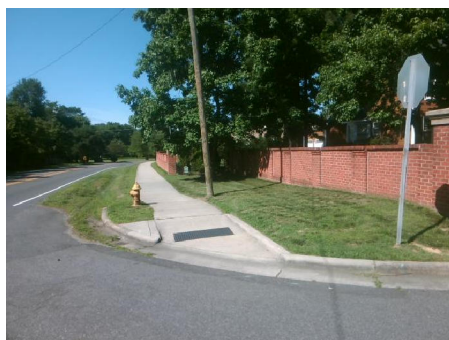
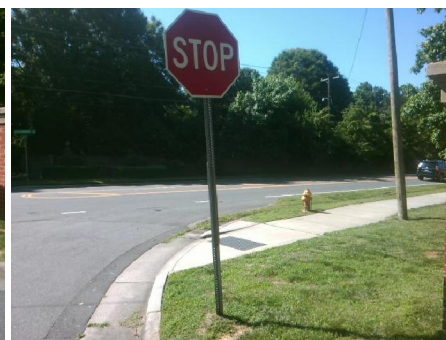
Compliance	Description	Data	Compliance	Description	Data
N/A	Ramp Length (in)	89.0	N/A	Grade Break?	N/A
Yes	Ramp Width (in)	69.0	N/A	Grade Break Slope (%)	0.0
Yes	Ramp Slope (%)	2.2	N/A	Grade Break XSlope (%)	0.0
No	Ramp XSlope (%)	2.6			
N/A	Flare Type LT	N/A	N/A	Flare Type RT	N/A
N/A	Flare Slope LT (%)	N/A	N/A	Flare Slope RT (%)	0.0
N/A	Flare Traversable LT?	N/A	N/A	Flare Traversable RT?	N/A
N/A	Landing Length (in)	0.0	N/A	DWS Provided?	N/A
N/A	Landing Width (in)	0.0	N/A	DWS Contrast?	N/A
N/A	Landing Slope (%)	0.0	N/A	DWS Length (in)	N/A
N/A	Landing X Slope (%)	0.0	N/A	DWS Full Width?	N/A
N/A	Landing Curb? (Y/N)	N/A	N/A	DWS Offset LT (in)	N/A
N/A	Shared Landing?	N/A	N/A	DWS Offset RT (in)	N/A
N/A	Gutter Ponding?	0.0	N/A	Gutter Slope (%)	N/A
N/A	Gutter Lip Ht (in)	0.0	N/A	Gutter X Slope (%)	N/A
N/A	Painted X Walk1?	No		Road Slope (%)	3.3
	X Walk 1 Direction	To NE		Road X Slope (%)	0.6
	X Walk 1 Width (in)	N/A		Clear Space?	N/A

X Walk 1 Slope (%)	3.3	N/A	Clear Space to XWalk (in)	N/A
	X Walk 1 X Slope (%)	0.6	N/A	Storm Grate/Utility Hazard?	N/A
N/A	Ramp inside XWalk1?	N/A		Storm Grate/Utility Type	
N/A	Any Obstructions?	N/A			N/A
	Obstruction Type		Yes	Surface Condition? (G/P)	Good
			N/A	Curb Slope (%)	9.2

Possible Solutions:

Remove & Replace Entire Ramp.

R304.5.3

Total Cost:

\$ 1600.00
