Access Compliance Report

Public Rights-of-Way

(Curb Ramps)

Intersection ID: 13639	Main Street: BRIAR_CREEK_RD	Cross Street: CENTRAL_AV	Location: NW
ADA ID: 73849626514E	Ramp Type: Perp	Initial Pass/Fail: Fail	Overall Compliance: No
Severity Score: 21.25			
Codes/Mitigation Info/Possible Solution		Field Measurements/Component Compliance

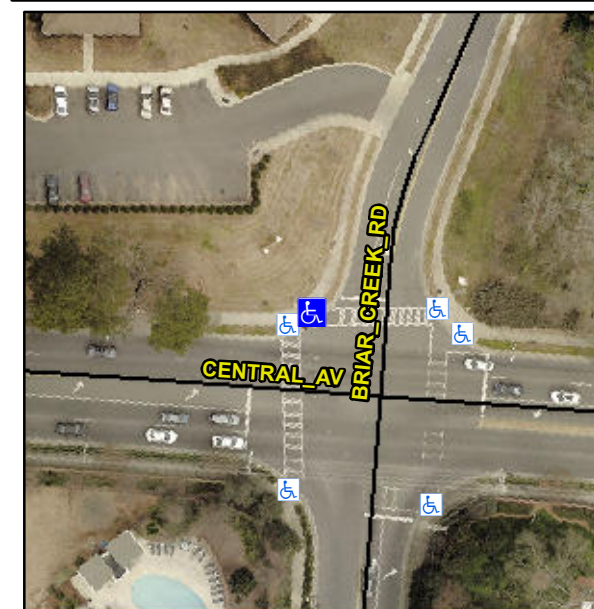
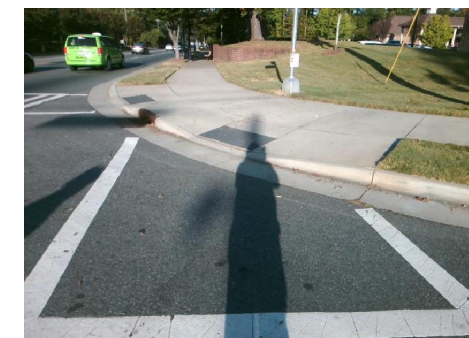
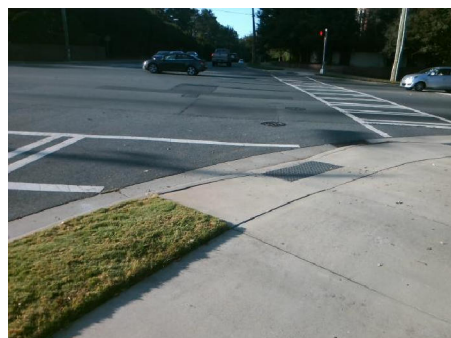
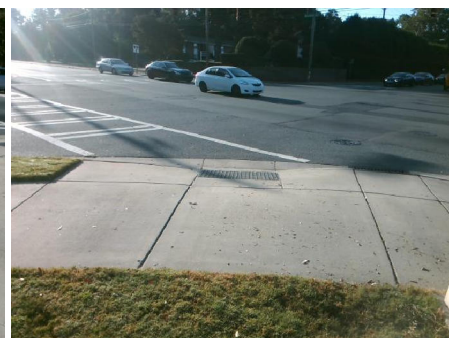
Not Found, R304.5.1, R304.2.2

Compliance	Description	Data	Compliance	Description	Data
N/A	Ramp Length (in)	49.0	No	Ramp Slope (%)	9.0
No	Ramp Width (in)	46.0	Yes	Ramp XSlope (%)	0.9
N/A	Flare Type LT	N/A	N/A	Flare Type RT	N/A
N/A	Flare Slope LT (%)	N/A	N/A	Flare Slope RT (%)	N/A
N/A	Flare Traversable LT?	N/A	N/A	Flare Traversable RT?	N/A
N/A	Landing Length (in)	N/A	N/A	DWS Provided?	N/A
N/A	Landing Width (in)	N/A	N/A	DWS Contrast?	N/A
N/A	Landing Slope (%)	N/A	N/A	DWS Length (in)	N/A
N/A	Landing X Slope (%)	N/A	N/A	DWS Full Width?	N/A
N/A	Landing Curb? (Y/N)	N/A	N/A	DWS Offset (in)	N/A
N/A	Shared Landing?	N/A			
N/A	Gutter Ponding?	N/A	N/A	Gutter Slope (%)	N/A
N/A	Gutter Lip Ht (in)	N/A	N/A	Gutter X Slope (%)	N/A
N/A	Painted X Walk1?	Yes	N/A	Painted X Walk2?	N/A
	X Walk 1 Direction	To E		X Walk 2 Direction	N/A
N/A	X Walk 1 Width (in)	93.0	N/A	X Walk 2 Width (in)	N/A
	X Walk 1 Slope (%)	5.2		X Walk 2 Slope (%)	N/A
	X Walk 1 X Slope (%)	0.9		X Walk 2 X Slope (%)	N/A

N/A	Ramp inside XWalk1?	Yes	N/A	Ramp inside XWalk2?	N/A
	Road Slope (%)	N/A	N/A	Clear Space?	N/A
	Road X Slope (%)	N/A	N/A	Clear Space to XWalk (in)	N/A
N/A	Any Obstructions?	N/A	N/A	Storm Grate/Utility Hazard?	N/A
	Obstruction Type			Storm Grate/Utility Type	
		N/A			N/A
			Yes	Surface Condition? (G/P)	Good

Possible Solutions:

Remove & Replace Entire Ramp.
