# Access Compliance Report

## Public Rights-of-Way

### (Curb Ramps)

Intersection ID: 13237	Main Street: W_PARK_AV	Cross Street: WILMORE_DR	Location: SW
ADA ID: 73892CCC4B91	Ramp Type: PerpDiag	Initial Pass/Fail: Fail	Overall Compliance: No
Severity Score: 12.5			
Codes/Mitigation Info/Possible Solution		Field Measurements/Component Compliance

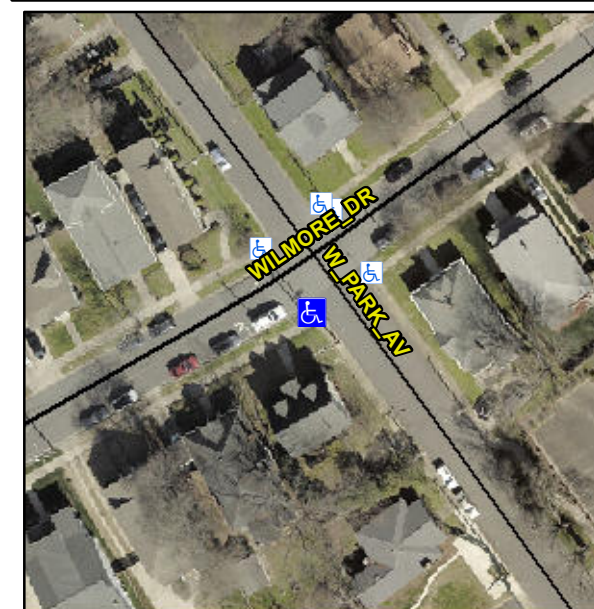
Compliance	Description	Data	Compliance	Description	Data
N/A	Ramp Length (in)	51.0	No	Ramp Slope (%)	11.1
Yes	Ramp Width (in)	50.0	Yes	Ramp XSlope (%)	0.8
N/A	Flare Type LT	N/A	N/A	Flare Type RT	N/A
N/A	Flare Slope LT (%)	N/A	N/A	Flare Slope RT (%)	N/A
N/A	Flare Traversable LT?	N/A	N/A	Flare Traversable RT?	N/A
N/A	Landing Length (in)	N/A	N/A	DWS Provided?	N/A
N/A	Landing Width (in)	N/A	N/A	DWS Contrast?	N/A
N/A	Landing Slope (%)	N/A	N/A	DWS Length (in)	N/A
N/A	Landing X Slope (%)	N/A	N/A	DWS Full Width?	N/A
N/A	Landing Curb? (Y/N)	N/A	N/A	DWS Offset (in)	N/A
N/A	Shared Landing?	N/A			
N/A	Gutter Ponding?	N/A	N/A	Gutter Slope (%)	N/A
N/A	Gutter Lip Ht (in)	2.0	N/A	Gutter X Slope (%)	N/A
N/A	Painted X Walk1?	No	N/A	Painted X Walk2?	No
	X Walk 1 Direction	To NE		X Walk 2 Direction	To NW
N/A	X Walk 1 Width (in)	N/A	N/A	X Walk 2 Width (in)	N/A
	X Walk 1 Slope (%)	6.0		X Walk 2 Slope (%)	11.1
	X Walk 1 X Slope (%)	2.9		X Walk 2 X Slope (%)	2.3

N/A	Ramp inside XWalk1?	N/A	N/A	Ramp inside XWalk2?	N/A
	Road Slope (%)	1.3	N/A	Clear Space?	N/A
	Road X Slope (%)	7.4	N/A	Clear Space to XWalk (in)	N/A
N/A	Any Obstructions?	N/A	N/A	Storm Grate/Utility Hazard?	N/A
	Obstruction Type			Storm Grate/Utility Type	
		N/A			N/A
		Yes		Surface Condition? (G/P)	Good

Possible Solutions:

**Remove & Replace Curb Ramp With Two New Directional Ramps or Equivalent.**

**R304.2.2**

Total Cost: \$ 3200.00
