Access Compliance Report

Public Rights-of-Way

(Curb Ramps)

Intersection ID: 8459	Main Street: KENTBROOK_DR	Cross Street: SPRINGVIEW_RD	Location: SW
ADA ID: 73935E254465	Ramp Type: BlendTrans1	Initial Pass/Fail: Fail	Overall Compliance: No
Severity Score: 21.25			
Codes/Mitigation Info/Possible Solution		Field Measurements/Component Compliance

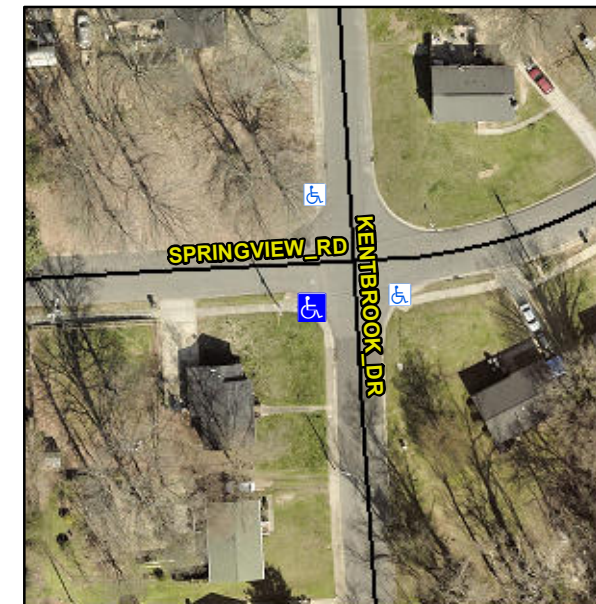
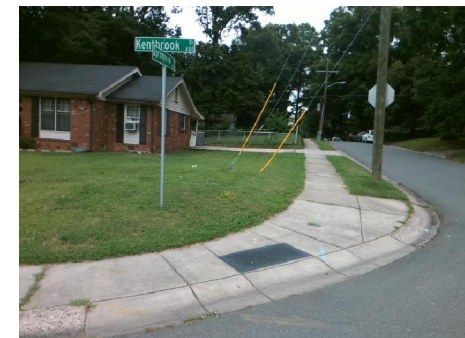
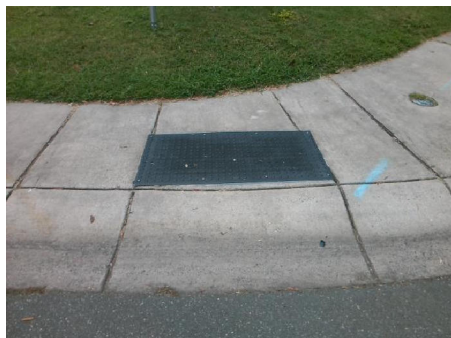
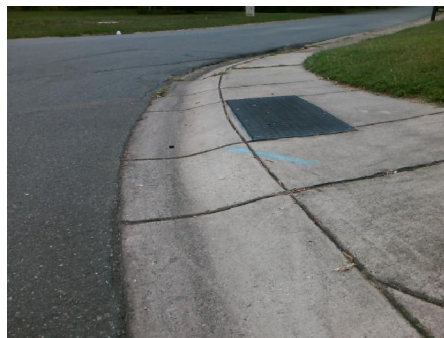
Not Found, R304.5.1, R304.5.3

Compliance	Description	Data	Compliance	Description	Data
N/A	Ramp Length (in)	52.0	Yes	BlendTrans Slope (%)	2.0
No	Ramp Width (in)	40.0	No	BlendTrans XSlope (%)	6.8
N/A	Flare Type LT	N/A	N/A	Flare Type RT	N/A
N/A	Flare Slope LT (%)	N/A	N/A	Flare Slope RT (%)	N/A
N/A	Flare Traversable LT?	N/A	N/A	Flare Traversable RT?	N/A
N/A	Landing Length (in)	N/A	N/A	DWS Provided?	N/A
N/A	Landing Width (in)	N/A	N/A	DWS Contrast?	N/A
N/A	Landing Slope (%)	N/A	N/A	DWS Length (in)	N/A
N/A	Landing X Slope (%)	N/A	N/A	DWS Full Width?	N/A
N/A	Landing Curb? (Y/N)	N/A	N/A	DWS Offset (in)	N/A
N/A	Shared Landing?	N/A			
N/A	Gutter Ponding?	N/A	N/A	Gutter Slope (%)	N/A
N/A	Gutter Lip Ht (in)	1.0	N/A	Gutter X Slope (%)	N/A
N/A	Painted X Walk1?	No	N/A	Painted X Walk2?	No
	X Walk 1 Direction	To E		X Walk 2 Direction	To N
	X Walk 1 Width (in)	N/A		X Walk 2 Width (in)	N/A
	X Walk 1 Slope (%)	4.0		X Walk 2 Slope (%)	7.8
	X Walk 1 X Slope (%)	7.3		X Walk 2 X Slope (%)	1.6

N/A	Ramp inside XWalk1?	N/A	N/A	Ramp inside XWalk2?	N/A
	Road Slope (%)	6.0		Clear Space?	N/A
	Road X Slope (%)	8.8	N/A	Clear Space to XWalk (in)	N/A
N/A	Any Obstructions?	N/A	N/A	Storm Grate/Utility Hazard?	N/A
	Obstruction Type			Storm Grate/Utility Type	
		N/A			N/A
			Yes	Surface Condition? (G/P)	Good
			No	Curb Slope (%)	23.4

Possible Solutions:

Remove & Replace Curb Ramp With Two New Directional Ramps or Equivalent.
