Access Compliance Report

Public Rights-of-Way

(Curb Ramps)

Intersection ID: 3258	Main Street: GLEN_HOPE_LN	Cross Street: SHADOW_PINE_DR	Location: E
ADA ID: 739BC6EF07D3	Ramp Type: Perp	Initial Pass/Fail: Fail	Overall Compliance: No
		Severity Score: 10

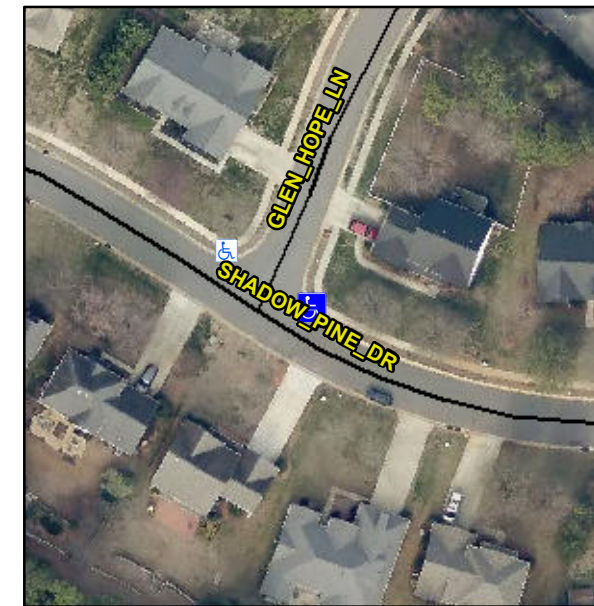
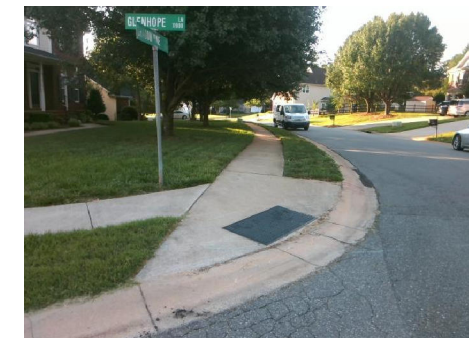
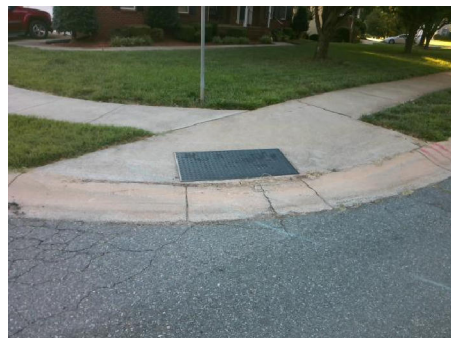
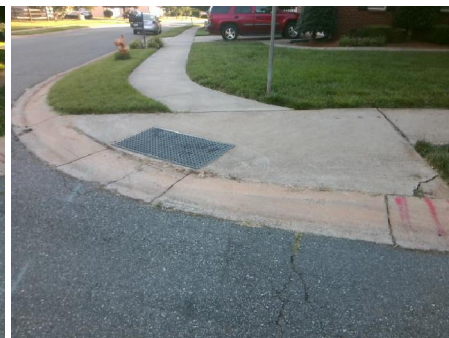
Not Found, R304.5.1, R304.5.3

Compliance	Description	Data	Compliance	Description	Data
N/A	Ramp Length (in)	45.0	Yes	Ramp Slope (%)	6.0
No	Ramp Width (in)	45.5	No	Ramp XSlope (%)	3.6
N/A	Flare Type LT	N/A	N/A	Flare Type RT	N/A
N/A	Flare Slope LT (%)	N/A	N/A	Flare Slope RT (%)	N/A
N/A	Flare Traversable LT?	N/A	N/A	Flare Traversable RT?	N/A
N/A	Landing Length (in)	N/A	N/A	DWS Provided?	N/A
N/A	Landing Width (in)	N/A	N/A	DWS Contrast?	N/A
N/A	Landing Slope (%)	N/A	N/A	DWS Length (in)	N/A
N/A	Landing X Slope (%)	N/A	N/A	DWS Full Width?	N/A
N/A	Landing Curb? (Y/N)	N/A	N/A	DWS Offset (in)	N/A
N/A	Shared Landing?	N/A			
N/A	Gutter Ponding?	N/A	N/A	Gutter Slope (%)	N/A
N/A	Gutter Lip Ht (in)	N/A	N/A	Gutter X Slope (%)	N/A
N/A	Painted X Walk1?	No	N/A	Painted X Walk2?	N/A
	X Walk 1 Direction	To NW		X Walk 2 Direction	N/A
N/A	X Walk 1 Width (in)	N/A	N/A	X Walk 2 Width (in)	N/A
	X Walk 1 Slope (%)	0.8		X Walk 2 Slope (%)	N/A
	X Walk 1 X Slope (%)	5.8		X Walk 2 X Slope (%)	N/A

N/A	Ramp inside XWalk1?	N/A	N/A	Ramp inside XWalk2?	N/A
	Road Slope (%)	N/A	N/A	Clear Space?	N/A
	Road X Slope (%)	N/A	N/A	Clear Space to XWalk (in)	N/A
N/A	Any Obstructions?	N/A	N/A	Storm Grate/Utility Hazard?	N/A
	Obstruction Type			Storm Grate/Utility Type	
		N/A			N/A
			Yes	Surface Condition? (G/P)	Good

Remove & Replace Entire Ramp.
