Access Compliance Report

Public Rights-of-Way

(Curb Ramps)

Intersection ID: 11680	Main Street: PARKWOOD_AV	Cross Street: UNION_ST	Location: NW
ADA ID: 739C85C35FBB	Ramp Type: Perp	Initial Pass/Fail: Fail	Overall Compliance: No
Severity Score: 17.5			
Codes/Mitigation Info/Possible Solution		Field Measurements/Component Compliance

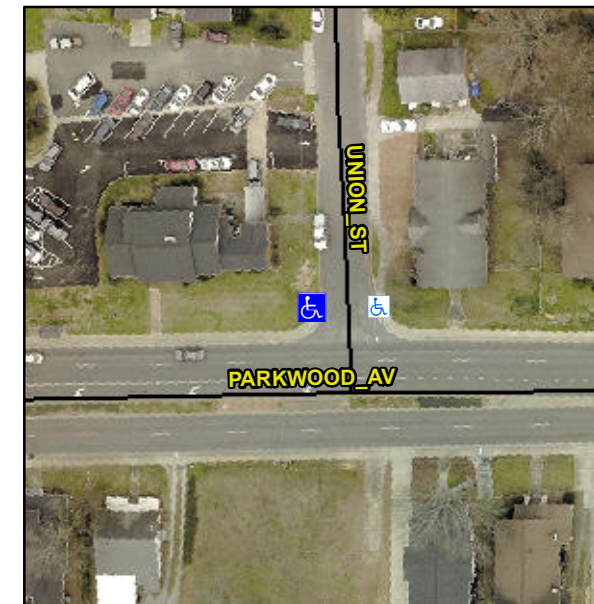
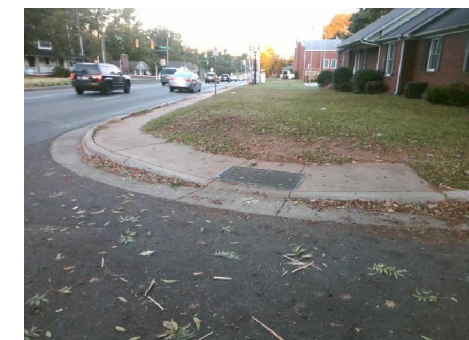
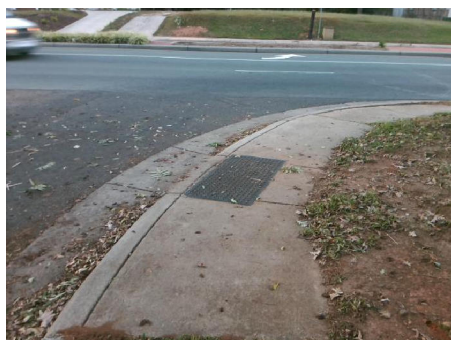
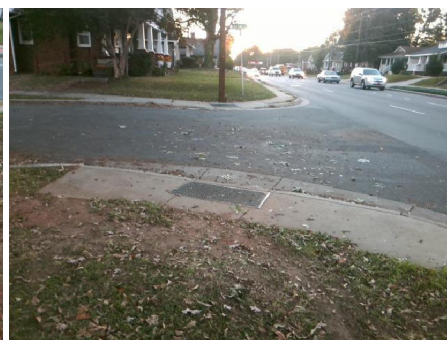
Not Found, R304.5.1

Compliance	Description	Data	Compliance	Description	Data
N/A	Ramp Length (in)	46.5	Yes	Ramp Slope (%)	6.4
No	Ramp Width (in)	35.0	Yes	Ramp XSlope (%)	1.1
N/A	Flare Type LT	N/A	N/A	Flare Type RT	N/A
N/A	Flare Slope LT (%)	N/A	N/A	Flare Slope RT (%)	N/A
N/A	Flare Traversable LT?	N/A	N/A	Flare Traversable RT?	N/A
N/A	Landing Length (in)	N/A	N/A	DWS Provided?	N/A
N/A	Landing Width (in)	N/A	N/A	DWS Contrast?	N/A
N/A	Landing Slope (%)	N/A	N/A	DWS Length (in)	N/A
N/A	Landing X Slope (%)	N/A	N/A	DWS Full Width?	N/A
N/A	Landing Curb? (Y/N)	N/A	N/A	DWS Offset (in)	N/A
N/A	Shared Landing?	N/A			
N/A	Gutter Ponding?	N/A	N/A	Gutter Slope (%)	N/A
N/A	Gutter Lip Ht (in)	N/A	N/A	Gutter X Slope (%)	N/A
N/A	Painted X Walk1?	No	N/A	Painted X Walk2?	N/A
	X Walk 1 Direction	To E		X Walk 2 Direction	N/A
N/A	X Walk 1 Width (in)	N/A	N/A	X Walk 2 Width (in)	N/A
	X Walk 1 Slope (%)	0.9		X Walk 2 Slope (%)	N/A
	X Walk 1 X Slope (%)	2.0		X Walk 2 X Slope (%)	N/A

N/A	Ramp inside XWalk1?	N/A	N/A	Ramp inside XWalk2?	N/A
	Road Slope (%)	N/A	N/A	Clear Space?	N/A
	Road X Slope (%)	N/A	N/A	Clear Space to XWalk (in)	N/A
N/A	Any Obstructions?	N/A	N/A	Storm Grate/Utility Hazard?	N/A
	Obstruction Type			Storm Grate/Utility Type	
		N/A			N/A
			Yes	Surface Condition? (G/P)	Good

Remove & Replace Entire Ramp.
