# Access Compliance Report

## Public Rights-of-Way

### (Curb Ramps)

Intersection ID: 44958	Main Street: N_TRYON_ST	Cross Street: OLD_CONCORD_RD	Location: SE
ADA ID: 73A1FEF6856B	Ramp Type: MedianPerp	Initial Pass/Fail: Fail	Overall Compliance: No
Severity Score: 12.5			
Codes/Mitigation Info/Possible Solution		Field Measurements/Component Compliance

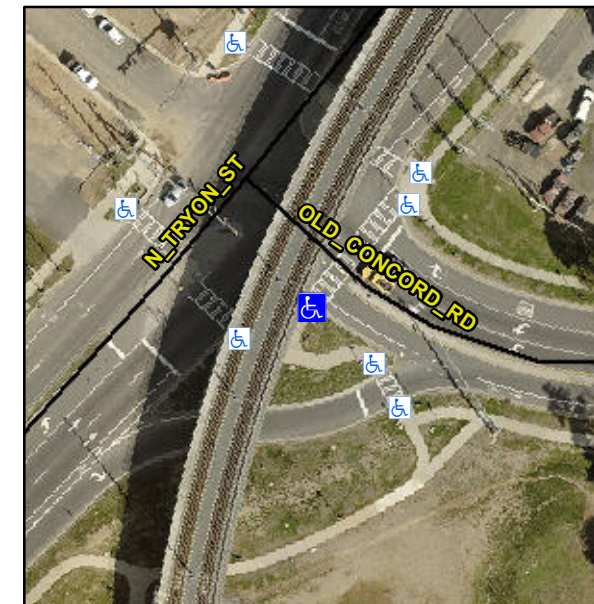
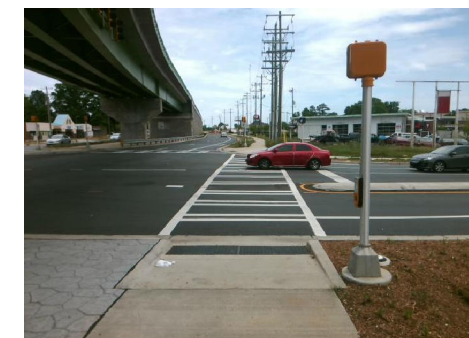
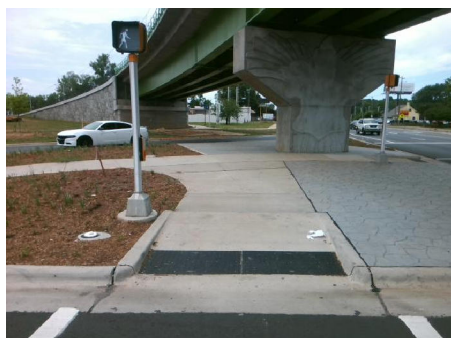
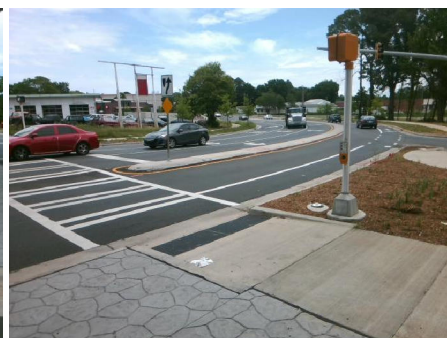
**Not Found, R304.2.2**

Compliance	Description	Data	Compliance	Description	Data
N/A	Ramp Length (in)	83.0	No	Ramp Slope (%)	8.7
Yes	Ramp Width (in)	96.0	Yes	Ramp XSlope (%)	0.0
N/A	Flare Type LT	N/A	N/A	Flare Type RT	N/A
N/A	Flare Slope LT (%)	N/A	N/A	Flare Slope RT (%)	N/A
N/A	Flare Traversable LT?	N/A	N/A	Flare Traversable RT?	N/A
N/A	Landing Length (in)	N/A	N/A	DWS Provided?	N/A
N/A	Landing Width (in)	N/A	N/A	DWS Contrast?	N/A
N/A	Landing Slope (%)	N/A	N/A	DWS Length (in)	N/A
N/A	Landing X Slope (%)	N/A	N/A	DWS Full Width?	N/A
N/A	Landing Curb? (Y/N)	N/A	N/A	DWS Offset (in)	N/A
N/A	Shared Landing?	N/A			
N/A	Gutter Ponding?	N/A	N/A	Gutter Slope (%)	N/A
N/A	Gutter Lip Ht (in)	N/A	N/A	Gutter X Slope (%)	N/A
N/A	Painted X Walk1?	Yes	N/A	Painted X Walk2?	N/A
	X Walk 1 Direction	To NE		X Walk 2 Direction	N/A
N/A	X Walk 1 Width (in)	118.0	N/A	X Walk 2 Width (in)	N/A
	X Walk 1 Slope (%)	2.0		X Walk 2 Slope (%)	N/A
	X Walk 1 X Slope (%)	1.5		X Walk 2 X Slope (%)	N/A

N/A	Ramp inside XWalk1?	Yes	N/A	Ramp inside XWalk2?	N/A
	Road Slope (%)	N/A	N/A	Clear Space?	N/A
	Road X Slope (%)	N/A	N/A	Clear Space to XWalk (in)	N/A
N/A	Any Obstructions?	N/A	N/A	Storm Grate/Utility Hazard?	N/A
	Obstruction Type			Storm Grate/Utility Type	
		N/A			N/A
		Yes		Surface Condition? (G/P)	Good

**Remove & Replace Entire Ramp.**
