Access Compliance Report

Public Rights-of-Way

(Curb Ramps)

Intersection ID: N/A	Main Street: OLD_CONCORD_RD	Cross Street: W_T_HARRIS_BV	Location: NW
ADA ID: 73A763F58D5C	Ramp Type: Directional1	Initial Pass/Fail: Pass	Overall Compliance: No
		Severity Score: 10

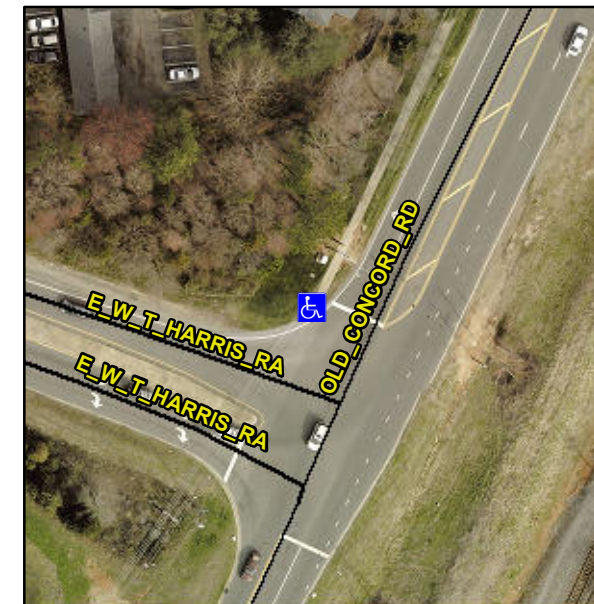
Compliance	Description	Data	Compliance	Description	Data
N/A	Ramp Length (in)	101.0	Yes	Grade Break?	Yes
Yes	Ramp Width (in)	57.5	Yes	Grade Break Slope (%)	0.0
Yes	Ramp Slope (%)	3.0	Yes	Grade Break XSlope (%)	1.2
Yes	Ramp XSlope (%)	0.7			
N/A	Flare Type LT	N/A	N/A	Flare Type RT	N/A
N/A	Flare Slope LT (%)	N/A	N/A	Flare Slope RT (%)	N/A
N/A	Flare Traversable LT?	N/A	N/A	Flare Traversable RT?	N/A
Yes	Landing Length (in)	57.5	No	DWS Provided?	No
Yes	Landing Width (in)	58.0	N/A	DWS Contrast?	No
No	Landing Slope (%)	3.3	N/A	DWS Length (in)	N/A
Yes	Landing X Slope (%)	1.3	N/A	DWS Full Width?	No
N/A	Landing Curb? (Y/N)	N/A	N/A	DWS Offset LT (in)	N/A
N/A	Shared Landing?	No	N/A	DWS Offset RT (in)	N/A
Yes	Gutter Ponding?	No	Yes	Gutter Slope (%)	4.0
Yes	Gutter Lip Ht (in)	0.0	Yes	Gutter X Slope (%)	0.6
N/A	Painted X Walk1?	No		Road Slope (%)	2.0
	X Walk 1 Direction	To S		Road X Slope (%)	3.2
	X Walk 1 Width (in)	N/A		Clear Space?	Yes

X Walk 1 Slope (%)	2.0	N/A	Clear Space to XWalk (in)	N/A
	X Walk 1 X Slope (%)	3.2	Yes	Storm Grate/Utility Hazard?	No
N/A	Ramp inside XWalk1?	N/A		Storm Grate/Utility Type	
Yes	Any Obstructions?	No			N/A
	Obstruction Type		Yes	Surface Condition? (G/P)	Good
			N/A	Curb Slope (%)	1.3

Remove & Replace Entire Ramp.
