Access Compliance Report

Public Rights-of-Way

(Curb Ramps)

Intersection ID: 43650	Main Street: CAMDEN_MEADOW_DR	Cross Street: BALLINDERRY_DR	Location: SW
ADA ID: 73AFCA648704	Ramp Type: PerpDiag	Initial Pass/Fail: Fail	Overall Compliance: No
		Severity Score: 12.5

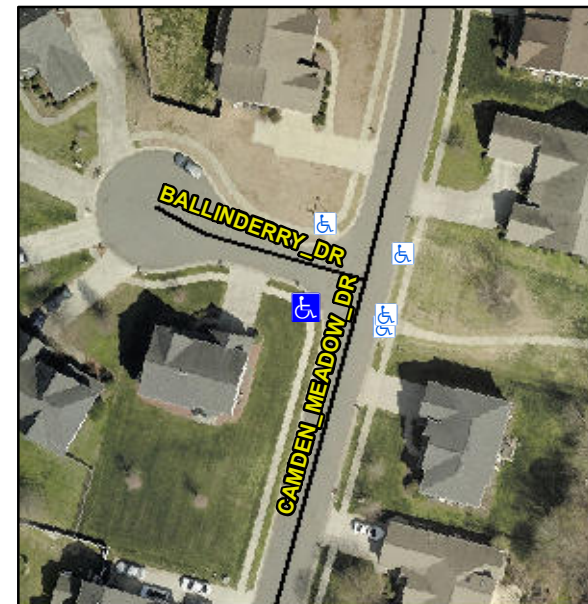
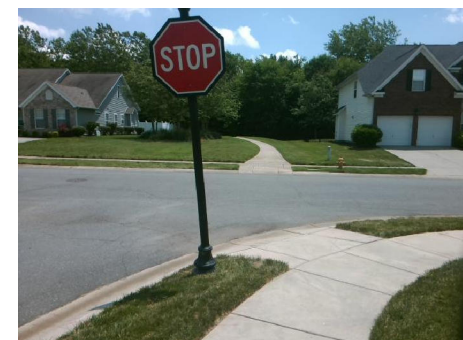
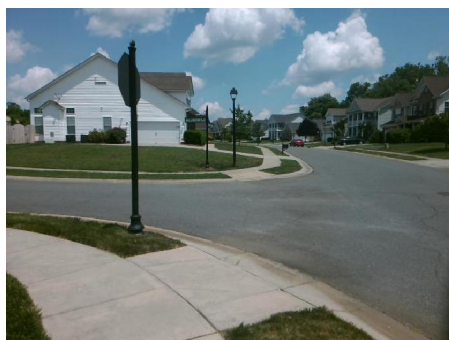
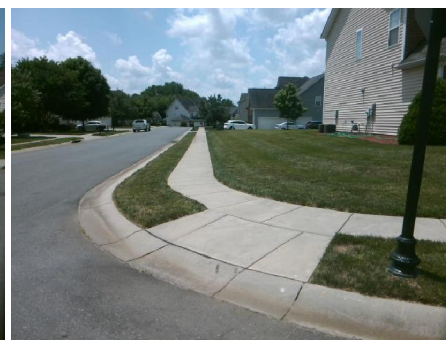
Not Found, R304.2.2

Compliance	Description	Data	Compliance	Description	Data
N/A	Ramp Length (in)	45.0	No	Ramp Slope (%)	9.9
Yes	Ramp Width (in)	51.0	Yes	Ramp XSlope (%)	1.1
N/A	Flare Type LT	N/A	N/A	Flare Type RT	N/A
N/A	Flare Slope LT (%)	N/A	N/A	Flare Slope RT (%)	N/A
N/A	Flare Traversable LT?	N/A	N/A	Flare Traversable RT?	N/A
N/A	Landing Length (in)	N/A	N/A	DWS Provided?	N/A
N/A	Landing Width (in)	N/A	N/A	DWS Contrast?	N/A
N/A	Landing Slope (%)	N/A	N/A	DWS Length (in)	N/A
N/A	Landing X Slope (%)	N/A	N/A	DWS Full Width?	N/A
N/A	Landing Curb? (Y/N)	N/A	N/A	DWS Offset (in)	N/A
N/A	Shared Landing?	N/A			
N/A	Gutter Ponding?	N/A	N/A	Gutter Slope (%)	N/A
N/A	Gutter Lip Ht (in)	N/A	N/A	Gutter X Slope (%)	N/A
N/A	Painted X Walk1?	No	N/A	Painted X Walk2?	No
	X Walk 1 Direction	To E		X Walk 2 Direction	To N
N/A	X Walk 1 Width (in)	N/A	N/A	X Walk 2 Width (in)	N/A
	X Walk 1 Slope (%)	4.1		X Walk 2 Slope (%)	2.2
	X Walk 1 X Slope (%)	1.0		X Walk 2 X Slope (%)	1.6

N/A	Ramp inside XWalk1?	N/A	N/A	Ramp inside XWalk2?	N/A
	Road Slope (%)	0.1	N/A	Clear Space?	N/A
	Road X Slope (%)	1.1	N/A	Clear Space to XWalk (in)	N/A
N/A	Any Obstructions?	N/A	N/A	Storm Grate/Utility Hazard?	N/A
	Obstruction Type			Storm Grate/Utility Type	
		N/A			N/A
		Yes		Surface Condition? (G/P)	Good

Remove & Replace Curb Ramp With Two New Directional Ramps or Equivalent.

Total Cost: \$ 3200.00
