Access Compliance Report

Public Rights-of-Way

(Curb Ramps)

Intersection ID: 6720	Main Street: DEBERRY_CT	Cross Street: ROUNDEAF_DR	Location:	E
ADA ID: 73BFAE7FAD00	Ramp Type: Perp	Initial Pass/Fail: Fail	Overall Compliance: No	Severity Score: 22.5
Codes/Mitigation Info/Possible Solution		Field Measurements/Component Compliance

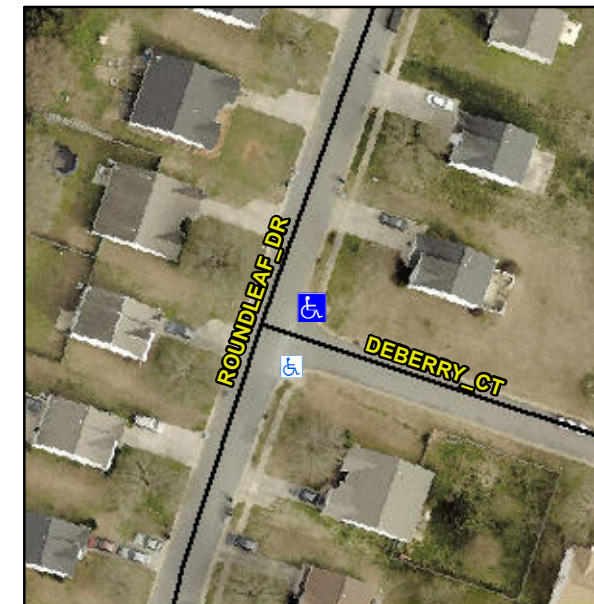
Compliance	Description	Data	Compliance	Description	Data
N/A	Ramp Length (in)	47.0	No	Ramp Slope (%)	8.4
No	Ramp Width (in)	41.0	No	Ramp XSlope (%)	2.3
N/A	Flare Type LT	N/A	N/A	Flare Type RT	N/A
N/A	Flare Slope LT (%)	N/A	N/A	Flare Slope RT (%)	N/A
N/A	Flare Traversable LT?	N/A	N/A	Flare Traversable RT?	N/A
N/A	Landing Length (in)	N/A	N/A	DWS Provided?	N/A
N/A	Landing Width (in)	N/A	N/A	DWS Contrast?	N/A
N/A	Landing Slope (%)	N/A	N/A	DWS Length (in)	N/A
N/A	Landing X Slope (%)	N/A	N/A	DWS Full Width?	N/A
N/A	Landing Curb? (Y/N)	N/A	N/A	DWS Offset (in)	N/A
N/A	Shared Landing?	N/A			
N/A	Gutter Ponding?	N/A	N/A	Gutter Slope (%)	N/A
N/A	Gutter Lip Ht (in)	N/A	N/A	Gutter X Slope (%)	N/A
N/A	Painted X Walk1?	No	N/A	Painted X Walk2?	N/A
	X Walk 1 Direction	To E		X Walk 2 Direction	N/A
N/A	X Walk 1 Width (in)	N/A	N/A	X Walk 2 Width (in)	N/A
	X Walk 1 Slope (%)	0.1		X Walk 2 Slope (%)	N/A
	X Walk 1 X Slope (%)	2.3		X Walk 2 X Slope (%)	N/A

N/A	Ramp inside XWalk1?	N/A	N/A	Ramp inside XWalk2?	N/A
	Road Slope (%)	N/A	N/A	Clear Space?	N/A
	Road X Slope (%)	N/A	N/A	Clear Space to XWalk (in)	N/A
N/A	Any Obstructions?	N/A	N/A	Storm Grate/Utility Hazard?	N/A
	Obstruction Type			Storm Grate/Utility Type	
		N/A			N/A
			Yes	Surface Condition? (G/P)	Good

Possible Solutions:

Remove & Replace Entire Ramp.
