Access Compliance Report

Public Rights-of-Way

(Curb Ramps)

Intersection ID: 10038345	Main Street: SOUTH_BV	Cross Street: N/A	Location: S
ADA ID: 73C2233863FE	Ramp Type: Perp	Initial Pass/Fail: Fail	Overall Compliance: No
Severity Score: 25			
Codes/Mitigation Info/Possible Solution		Field Measurements/Component Compliance

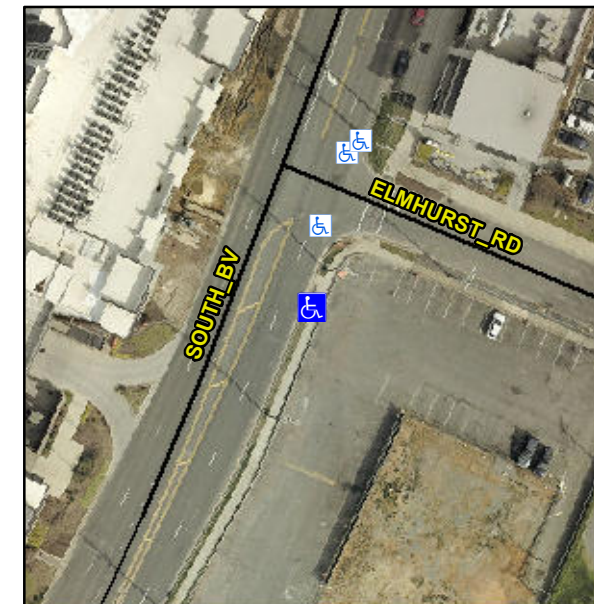
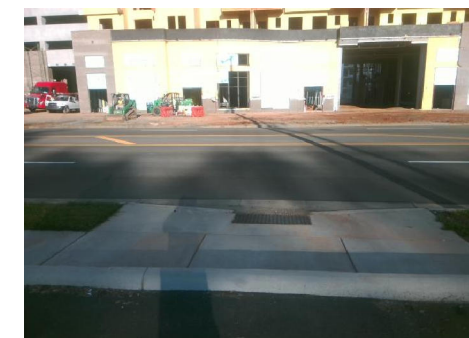
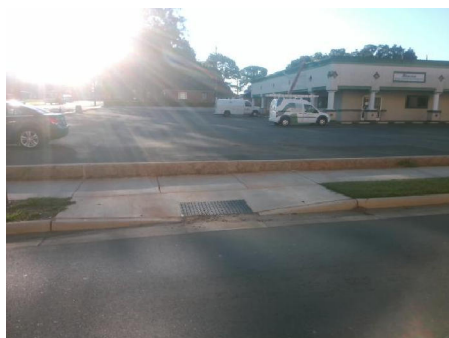
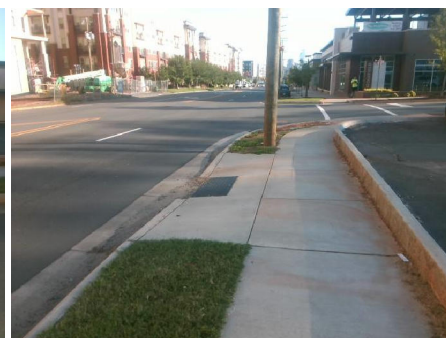
Compliance	Description	Data	Compliance	Description	Data
N/A	Ramp Length (in)	46.0	No	Ramp Slope (%)	12.4
Yes	Ramp Width (in)	48.0	Yes	Ramp XSlope (%)	0.7
N/A	Flare Type LT	N/A	N/A	Flare Type RT	N/A
N/A	Flare Slope LT (%)	N/A	N/A	Flare Slope RT (%)	N/A
N/A	Flare Traversable LT?	N/A	N/A	Flare Traversable RT?	N/A
N/A	Landing Length (in)	N/A	N/A	DWS Provided?	N/A
N/A	Landing Width (in)	N/A	N/A	DWS Contrast?	N/A
N/A	Landing Slope (%)	N/A	N/A	DWS Length (in)	N/A
N/A	Landing X Slope (%)	N/A	N/A	DWS Full Width?	N/A
N/A	Landing Curb? (Y/N)	N/A	N/A	DWS Offset (in)	N/A
N/A	Shared Landing?	N/A			
N/A	Gutter Ponding?	N/A	N/A	Gutter Slope (%)	N/A
N/A	Gutter Lip Ht (in)	N/A	N/A	Gutter X Slope (%)	N/A
N/A	Painted X Walk1?	No	N/A	Painted X Walk2?	N/A
	X Walk 1 Direction	To NW		X Walk 2 Direction	N/A
N/A	X Walk 1 Width (in)	N/A	N/A	X Walk 2 Width (in)	N/A
	X Walk 1 Slope (%)	2.8		X Walk 2 Slope (%)	N/A
	X Walk 1 X Slope (%)	0.1		X Walk 2 X Slope (%)	N/A

Possible Solutions:

Remove & Replace Entire Ramp.

R304.2.2
