# Access Compliance Report

## Public Rights-of-Way

### (Curb Ramps)

Intersection ID: N/A	Main Street: BARRINGER_DR	Cross Street: MAYFLOWER_RD	Location: SE
ADA ID: 73CD50552DD1	Ramp Type: Perp	Initial Pass/Fail: Pass	Overall Compliance: No
Codes/Mitigation Info/Possible Solution		Field Measurements/Component Compliance

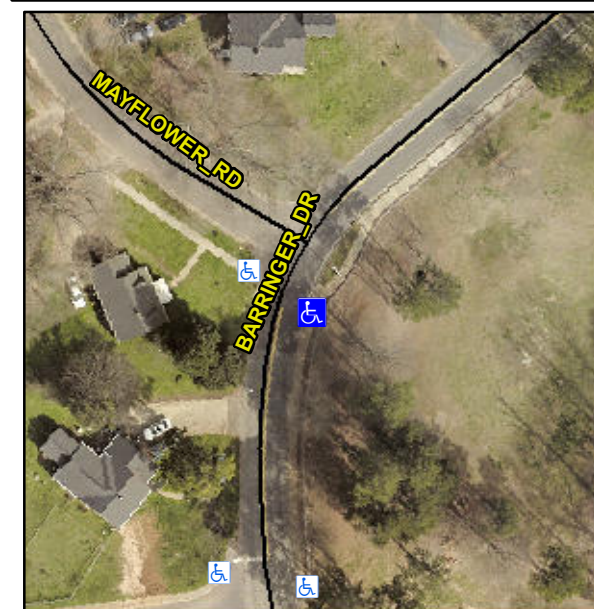
Compliance	Description	Data	Compliance	Description	Data
N/A	Ramp Length (in)	72.0	Yes	Ramp Slope (%)	7.5
Yes	Ramp Width (in)	48.0	Yes	Ramp XSlope (%)	1.7
N/A	Flare Type LT	Sloped	N/A	Flare Type RT	N/A
N/A	Flare Slope LT (%)	3.2	Yes	Flare Slope RT (%)	3.7
N/A	Flare Traversable LT?	Yes	N/A	Flare Traversable RT?	Yes
No	Landing Length (in)	N/A	Yes	DWS Provided?	Yes
No	Landing Width (in)	N/A	Yes	DWS Contrast?	Yes
No	Landing Slope (%)	N/A	Yes	DWS Length (in)	24.0
No	Landing X Slope (%)	N/A	Yes	DWS Full Width?	Yes
N/A	Landing Curb? (Y/N)	No	Yes	DWS Offset (in)	1.0
N/A	Shared Landing?	No			
No	Gutter Ponding?	Yes	No	Gutter Slope (%)	5.9
Yes	Gutter Lip Ht (in)	0.0	Yes	Gutter X Slope (%)	0.1
N/A	Painted X Walk1?	No	N/A	Painted X Walk2?	N/A
	X Walk 1 Direction	To NW		X Walk 2 Direction	N/A
N/A	X Walk 1 Width (in)	N/A	N/A	X Walk 2 Width (in)	N/A
	X Walk 1 Slope (%)	7.0		X Walk 2 Slope (%)	N/A
	X Walk 1 X Slope (%)	0.8		X Walk 2 X Slope (%)	N/A

N/A	Ramp inside XWalk1?	N/A	N/A	Ramp inside XWalk2?	N/A
	Road Slope (%)	N/A	N/A	Clear Space?	Yes
	Road X Slope (%)	N/A	N/A	Clear Space to XWalk (in)	N/A
Yes	Any Obstructions?	No	Yes	Storm Grate/Utility Hazard?	No
	Obstruction Type			Storm Grate/Utility Type	
		N/A			N/A
			Yes	Surface Condition? (G/P)	Good

Possible Solutions:

**Install Landing. Remove & Replace Gutter.**

**R304.2.1, R304.2.2-Perp, R304.3.2-Para, R304.5.3, R302.7, R304.5.4**

Total Cost: \$ 1150.00
