Access Compliance Report

Public Rights-of-Way

(Curb Ramps)

Intersection ID: 14393	Main Street: BERKELEY_AV	Cross Street: LEXINGTON_AV	Location: SE
ADA ID: 73D035645584	Ramp Type: Perp	Initial Pass/Fail: Fail	Overall Compliance: No
Severity Score: 1.25			
Codes/Mitigation Info/Possible Solution		Field Measurements/Component Compliance

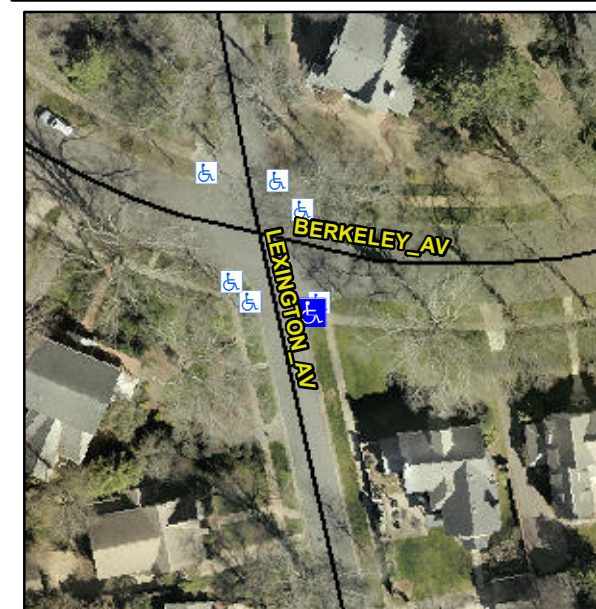
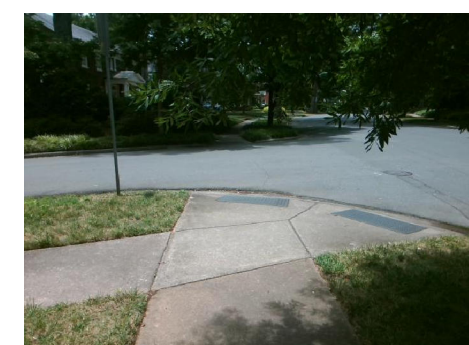
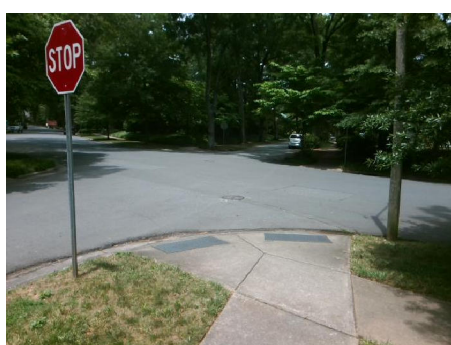
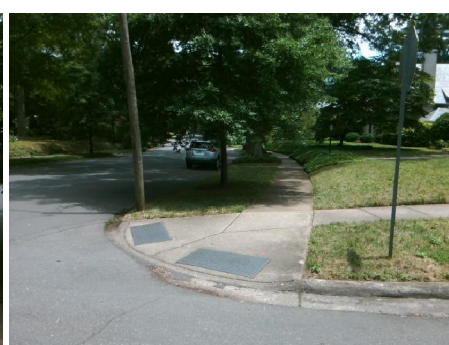
Not Found, R304.5.3

Compliance	Description	Data	Compliance	Description	Data
N/A	Ramp Length (in)	27.0	Yes	Ramp Slope (%)	6.7
Yes	Ramp Width (in)	62.0	No	Ramp XSlope (%)	3.3
N/A	Flare Type LT	N/A	N/A	Flare Type RT	N/A
N/A	Flare Slope LT (%)	N/A	N/A	Flare Slope RT (%)	N/A
N/A	Flare Traversable LT?	N/A	N/A	Flare Traversable RT?	N/A
N/A	Landing Length (in)	N/A	N/A	DWS Provided?	N/A
N/A	Landing Width (in)	N/A	N/A	DWS Contrast?	N/A
N/A	Landing Slope (%)	N/A	N/A	DWS Length (in)	N/A
N/A	Landing X Slope (%)	N/A	N/A	DWS Full Width?	N/A
N/A	Landing Curb? (Y/N)	N/A	N/A	DWS Offset (in)	N/A
N/A	Shared Landing?	N/A			
N/A	Gutter Ponding?	N/A	N/A	Gutter Slope (%)	N/A
N/A	Gutter Lip Ht (in)	N/A	N/A	Gutter X Slope (%)	N/A
N/A	Painted X Walk1?	No	N/A	Painted X Walk2?	N/A
	X Walk 1 Direction	To W		X Walk 2 Direction	N/A
N/A	X Walk 1 Width (in)	N/A	N/A	X Walk 2 Width (in)	N/A
	X Walk 1 Slope (%)	9.8		X Walk 2 Slope (%)	N/A
	X Walk 1 X Slope (%)	1.4		X Walk 2 X Slope (%)	N/A

N/A	Ramp inside XWalk1?	N/A	N/A	Ramp inside XWalk2?	N/A
	Road Slope (%)	N/A	N/A	Clear Space?	N/A
	Road X Slope (%)	N/A	N/A	Clear Space to XWalk (in)	N/A
N/A	Any Obstructions?	N/A	N/A	Storm Grate/Utility Hazard?	N/A
	Obstruction Type			Storm Grate/Utility Type	
		N/A			N/A
		Yes		Surface Condition? (G/P)	Good

Possible Solutions:

Remove & Replace Entire Ramp.
