Access Compliance Report

Public Rights-of-Way

(Curb Ramps)

Intersection ID: 10037649	Main Street: SEVENTY SEVEN CENTER DR	Cross Street: N/A	Location: SW
ADA ID: 73D5C21FDD26	Ramp Type: Perp	Initial Pass/Fail: Fail	Overall Compliance: No
Severity Score: 22.5			
Codes/Mitigation Info/Possible Solution		Field Measurements/Component Compliance

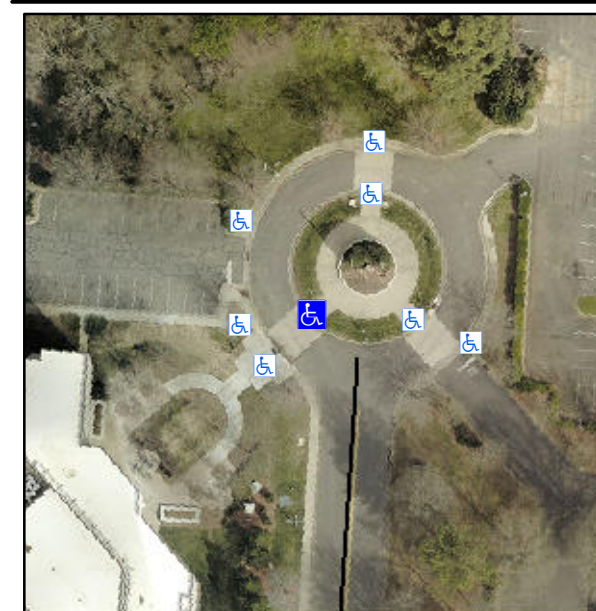
R304.5.1, R304.2.2, R304.5.3

Compliance	Description	Data	Compliance	Description	Data
N/A	Ramp Length (in)	58.0	No	Ramp Slope (%)	8.8
No	Ramp Width (in)	38.0	No	Ramp XSlope (%)	2.5
N/A	Flare Type LT	N/A	N/A	Flare Type RT	N/A
N/A	Flare Slope LT (%)	N/A	N/A	Flare Slope RT (%)	N/A
N/A	Flare Traversable LT?	N/A	N/A	Flare Traversable RT?	N/A
N/A	Landing Length (in)	N/A	N/A	DWS Provided?	N/A
N/A	Landing Width (in)	N/A	N/A	DWS Contrast?	N/A
N/A	Landing Slope (%)	N/A	N/A	DWS Length (in)	N/A
N/A	Landing X Slope (%)	N/A	N/A	DWS Full Width?	N/A
N/A	Landing Curb? (Y/N)	N/A	N/A	DWS Offset (in)	N/A
N/A	Shared Landing?	N/A			
N/A	Gutter Ponding?	N/A	N/A	Gutter Slope (%)	N/A
N/A	Gutter Lip Ht (in)	N/A	N/A	Gutter X Slope (%)	N/A
N/A	Painted X Walk1?	No	N/A	Painted X Walk2?	N/A
	X Walk 1 Direction	To SW		X Walk 2 Direction	N/A
N/A	X Walk 1 Width (in)	N/A	N/A	X Walk 2 Width (in)	N/A
	X Walk 1 Slope (%)	1.1		X Walk 2 Slope (%)	N/A
	X Walk 1 X Slope (%)	1.1		X Walk 2 X Slope (%)	N/A

Possible Solutions:

Remove & Replace Entire Ramp.
