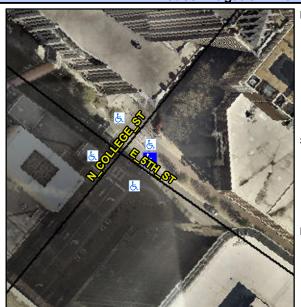
Not Found, R304.5.3, R304.2.2-Perp,
R304.3.2-Para, R304.2.3

Field Measurements/Component Compliance					
Compliance Description		Data	Compliance Description		Data
N/A	Ramp Length (in)	34.0	Yes	Ramp Slope (%)	5.5
Yes	Ramp Width (in)	48.0	No	Ramp XSlope (%)	4.1
No	Flare Type Qurbed_WithWalkSurface		N/A	Flare Type RT	N/A
No	Flare Slope LT (%)	N/A	Yes	Flare Slope RT (%)	3.7
N/A	Flare Traversable LT?	No	N/A	Flare Traversable RT?	Yes
Yes	Landing Length (in)	48.0	Yes	DWS Provided?	Yes
Yes	Landing Width (in)	48.0	Yes	DWS Contrast?	Yes
No	Landing Slope (%)	3.6	Yes	DWS Length (in)	24.0
No	Landing X Slope (%)	3.9	Yes	DWS Full Width?	Yes
N/A	Landing Curb? (Y/N)	No	Yes	DWS Offset (in)	0.0
N/A	Shared Landing?	No			
Yes	Gutter Ponding?	No	Yes	Gutter Slope (%)	3.1
Yes	Gutter Lip Ht (in)	0.0	No	Gutter X Slope (%)	3.6
N/A	Painted X Walk1?	Yes	N/A	Painted X Walk2?	N/A
	X Walk 1 Direction	To SW		X Walk 2 Direction	N/A
N/A	X Walk 1 Width (in)	108.0	N/A	X Walk 2 Width (in)	N/A
	X Walk 1 Slope (%)	0.9		X Walk 2 Slope (%)	N/A

X Walk 1 X Slope (%)	3.4		X Walk 2 X Slope (%)	N/A
Yes	Ramp inside XWalk1?	Yes	N/A	Ramp inside XWalk2?	N/A
	Road Slope (%)	N/A	N/A	Clear Space?	Yes
	Road X Slope (%)	N/A	N/A	Clear Space to XWalk (in)	N/A
Yes	Any Obstructions?	No	Yes	Storm Grate/Utility Hazard?	No
	Obstruction Type		l	Storm Grate/Utility Type	
		N/A			N/A
			Yes	Surface Condition? (G/P)	Good

Remove & Replace Entire Ramp.
Remove & Replace Gutter.
