Access Compliance Report

Public Rights-of-Way

(Curb Ramps)

Intersection ID: 22532	Main Street: HARRISON_RD	Cross Street: HARRISONWOODS_PL	Location: NW
ADA ID: 73E78D6A0711	Ramp Type: PerpDiag	Initial Pass/Fail: Fail	Overall Compliance: No
Severity Score: 13.75			
Codes/Mitigation Info/Possible Solution		Field Measurements/Component Compliance

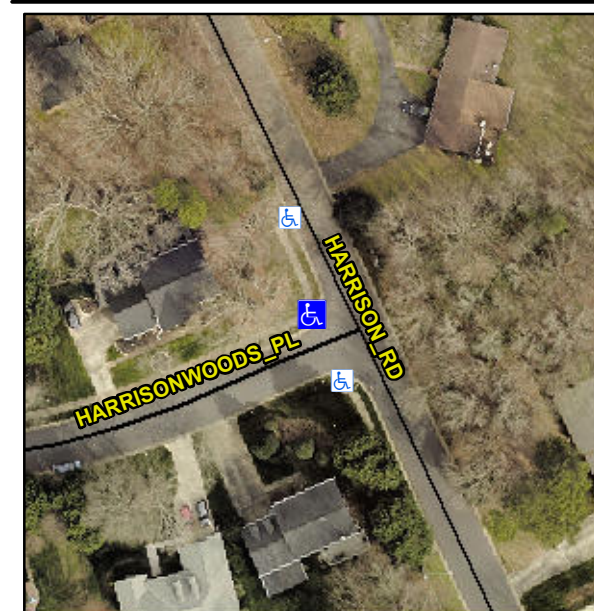
Not Found, R304.2.2, R304.5.3

Compliance	Description	Data	Compliance	Description	Data
N/A	Ramp Length (in)	49.0	No	Ramp Slope (%)	8.8
Yes	Ramp Width (in)	48.0	No	Ramp XSlope (%)	3.5
N/A	Flare Type LT	N/A	N/A	Flare Type RT	N/A
N/A	Flare Slope LT (%)	N/A	N/A	Flare Slope RT (%)	N/A
N/A	Flare Traversable LT?	N/A	N/A	Flare Traversable RT?	N/A
N/A	Landing Length (in)	N/A	N/A	DWS Provided?	N/A
N/A	Landing Width (in)	N/A	N/A	DWS Contrast?	N/A
N/A	Landing Slope (%)	N/A	N/A	DWS Length (in)	N/A
N/A	Landing X Slope (%)	N/A	N/A	DWS Full Width?	N/A
N/A	Landing Curb? (Y/N)	N/A	N/A	DWS Offset (in)	N/A
N/A	Shared Landing?	N/A			
N/A	Gutter Ponding?	N/A	N/A	Gutter Slope (%)	N/A
N/A	Gutter Lip Ht (in)	N/A	N/A	Gutter X Slope (%)	N/A
N/A	Painted X Walk1?	No	N/A	Painted X Walk2?	No
	X Walk 1 Direction	To SE		X Walk 2 Direction	To NE
N/A	X Walk 1 Width (in)	N/A	N/A	X Walk 2 Width (in)	N/A
	X Walk 1 Slope (%)	3.9		X Walk 2 Slope (%)	6.9
	X Walk 1 X Slope (%)	5.5		X Walk 2 X Slope (%)	0.2

N/A	Ramp inside XWalk1?	N/A	N/A	Ramp inside XWalk2?	N/A
	Road Slope (%)	2.6	N/A	Clear Space?	N/A
	Road X Slope (%)	5.7	N/A	Clear Space to XWalk (in)	N/A
N/A	Any Obstructions?	N/A	N/A	Storm Grate/Utility Hazard?	N/A
	Obstruction Type			Storm Grate/Utility Type	
		N/A			N/A
			Yes	Surface Condition? (G/P)	Good

Remove & Replace Curb Ramp With Two New Directional Ramps or Equivalent.
