# Access Compliance Report

## Public Rights-of-Way

### (Curb Ramps)

| Intersection ID: 46605 | Main Street: E_WOODLAWN_RD | Cross Street: PARK_RD_SHOPPING_CENTER_DR | Location: NW |

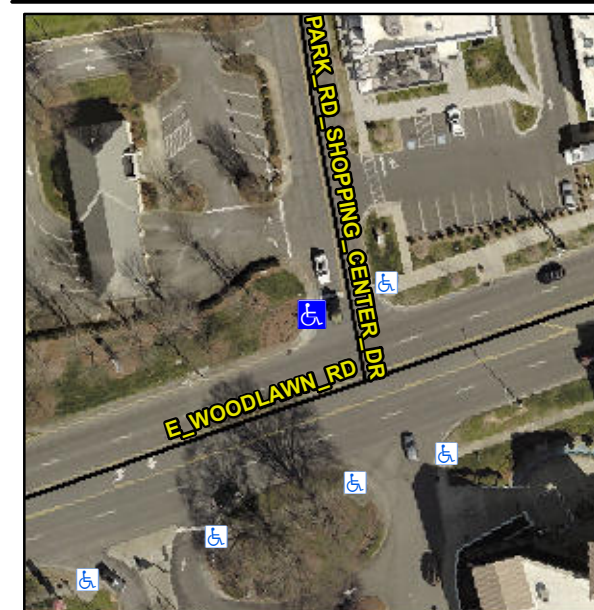
| ADA ID: 73E89328A850 | Ramp Type: Perp | Initial Pass/Fail: Fail | Overall Compliance: No |
| Severity Score: 8.75 | | | |

**Not Found, R304.5.1**

| Compliance | Description | Data | Compliance | Description | Data |
|---|---|---|---|---|---|
| No | Ramp Width (in) | 47.0 | Yes | Ramp XSlope (%) | 1.3 |

**Remove & Replace Entire Ramp.**

Total Cost: \$ 1850.00
