Access Compliance Report

Public Rights-of-Way

(Curb Ramps)

Intersection ID: 50532	Main Street: STRAUSE_DR	Cross Street: SAMLEN_LN	Location: NE
ADA ID: 73EA2EC5C72C	Ramp Type: PerpDiag	Initial Pass/Fail: Fail	Overall Compliance: No
		Severity Score: 8.75

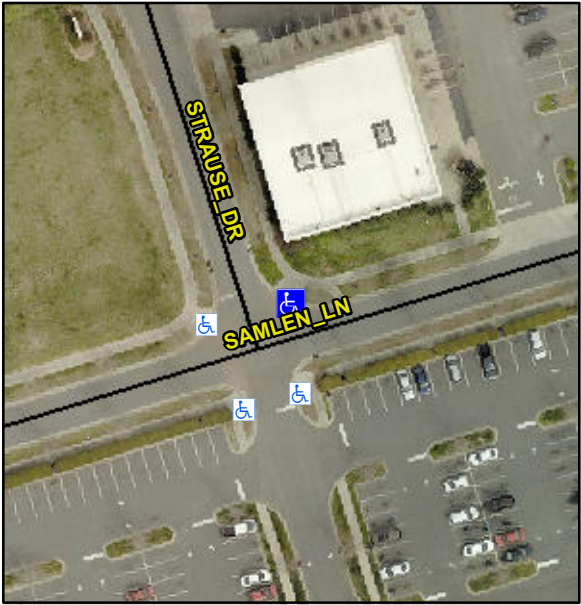
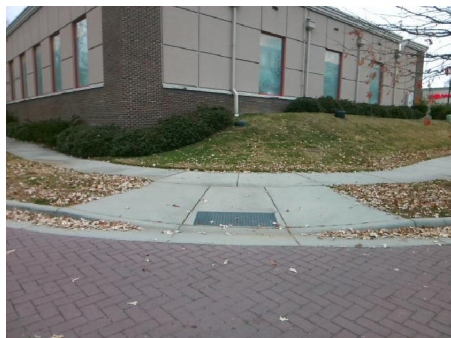
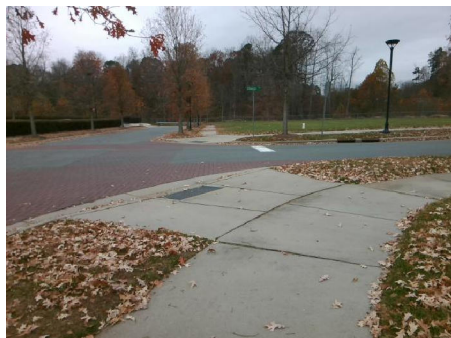
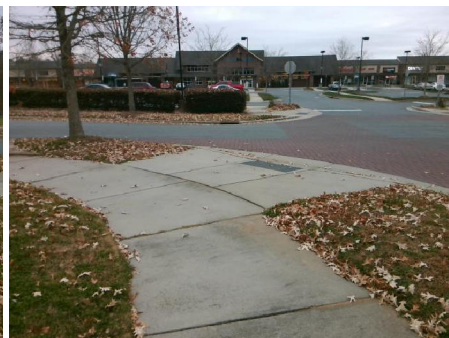
Possible Solutions:		Compliance	Description	Data
	Remove & Replace Curb Ramp With Two New Directional Ramps or Equivalent.		Yes	Ramp Length (in)	96.0
			No	Ramp Width (in)	45.0
			N/A	Flare Type LT	N/A
			N/A	Flare Slope LT (%)	N/A
			N/A	Flare Traversable LT?	N/A
			N/A	Landing Length (in)	N/A
			N/A	Landing Width (in)	N/A
			N/A	Landing Slope (%)	N/A
			N/A	Landing X Slope (%)	N/A
<p>Surveyor Notes:</p> <p>N/A</p> <p>PROW/ADA:</p> <p>Not Found, R304.5.1</p>			N/A	Flare Type RT	N/A
			N/A	Flare Slope RT (%)	N/A
			N/A	Flare Traversable RT?	N/A
			N/A	DWS Provided?	N/A
			N/A	DWS Contrast?	N/A
			N/A	DWS Length (in)	N/A
			N/A	DWS Full Width?	N/A
			N/A	DWS Offset (in)	N/A
			N/A	Shared Landing?	N/A
			N/A	Gutter Ponding?	N/A
			N/A	Gutter Lip Ht (in)	N/A
			N/A	Painted X Walk1?	Yes
				X Walk 1 Direction	To W
			N/A	X Walk 1 Width (in)	122.0

X Walk 1 Slope (%)	2.1
				X Walk 1 X Slope (%)	1.6
			N/A	Ramp inside XWalk1?	Yes
			N/A	Road Slope (%)	0.8
			N/A	Road X Slope (%)	1.0
			N/A	Any Obstructions?	N/A
				Obstruction Type	
			N/A		
			N/A		
			N/A		
			N/A		
			N/A		
			N/A		
			N/A		
			N/A		
			N/A		
Total Cost:		\$ 3200.00			
Street 1 Name	STRAUSE DR				
Stop Condition-Street 2	StopSign				
Street 2 Name	SAMLEN LN				
Stop Condition-Street 1	None				
			Yes	Surface Condition? (G/P)	Good
