# Access Compliance Report

## Public Rights-of-Way

### (Curb Ramps)

Intersection ID: 50584	Main Street: GREAT_LAUREL_RD	Cross Street: GRAND_FIR_RD	Location: SE
ADA ID: 73EE7C354C4E	Ramp Type: Perp	Initial Pass/Fail: Fail	Overall Compliance: No
Severity Score: 12.5			
Codes/Mitigation Info/Possible Solution		Field Measurements/Component Compliance

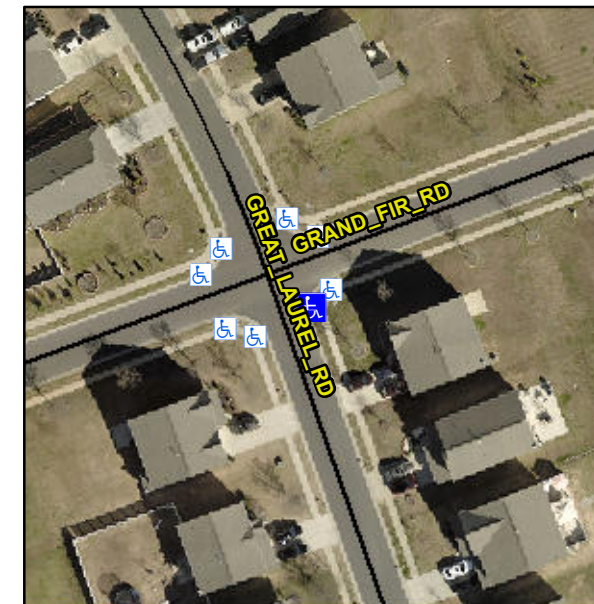
**Not Found, R304.2.2**

Compliance	Description	Data	Compliance	Description	Data
N/A	Ramp Length (in)	48.5	No	Ramp Slope (%)	9.1
Yes	Ramp Width (in)	48.0	Yes	Ramp XSlope (%)	0.0
N/A	Flare Type LT	N/A	N/A	Flare Type RT	N/A
N/A	Flare Slope LT (%)	N/A	N/A	Flare Slope RT (%)	N/A
N/A	Flare Traversable LT?	N/A	N/A	Flare Traversable RT?	N/A
N/A	Landing Length (in)	N/A	N/A	DWS Provided?	N/A
N/A	Landing Width (in)	N/A	N/A	DWS Contrast?	N/A
N/A	Landing Slope (%)	N/A	N/A	DWS Length (in)	N/A
N/A	Landing X Slope (%)	N/A	N/A	DWS Full Width?	N/A
N/A	Landing Curb? (Y/N)	N/A	N/A	DWS Offset (in)	N/A
N/A	Shared Landing?	N/A			
N/A	Gutter Ponding?	N/A	N/A	Gutter Slope (%)	N/A
N/A	Gutter Lip Ht (in)	N/A	N/A	Gutter X Slope (%)	N/A
N/A	Painted X Walk1?	No	N/A	Painted X Walk2?	N/A
	X Walk 1 Direction	To W		X Walk 2 Direction	N/A
N/A	X Walk 1 Width (in)	N/A	N/A	X Walk 2 Width (in)	N/A
	X Walk 1 Slope (%)	0.6		X Walk 2 Slope (%)	N/A
	X Walk 1 X Slope (%)	1.9		X Walk 2 X Slope (%)	N/A

**Remove & Replace Entire Ramp.**

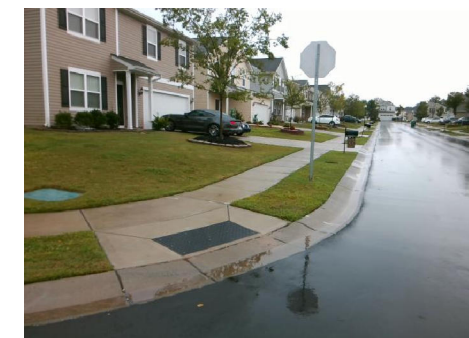
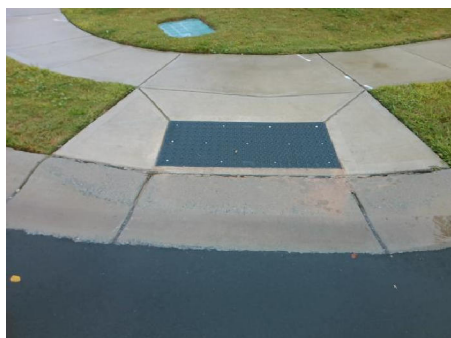
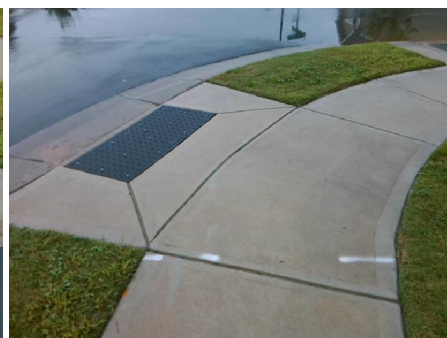
N/A	Ramp inside XWalk1?	N/A	N/A	Ramp inside XWalk2?	N/A
	Road Slope (%)	N/A	N/A	Clear Space?	N/A
	Road X Slope (%)	N/A	N/A	Clear Space to XWalk (in)	N/A
N/A	Any Obstructions?	N/A	N/A	Storm Grate/Utility Hazard?	N/A
	Obstruction Type			Storm Grate/Utility Type	
		N/A			N/A
			Yes	Surface Condition? (G/P)	Good
