Access Compliance Report

Public Rights-of-Way

(Curb Ramps)

Intersection ID: 7479	Main Street: COTTONWOOD_ST	Cross Street: JOE_ST	Location: SW
ADA ID: 73F57EA19121	Ramp Type: Perp	Initial Pass/Fail: Fail	Overall Compliance: No
Severity Score: 8.75			
Codes/Mitigation Info/Possible Solution		Field Measurements/Component Compliance

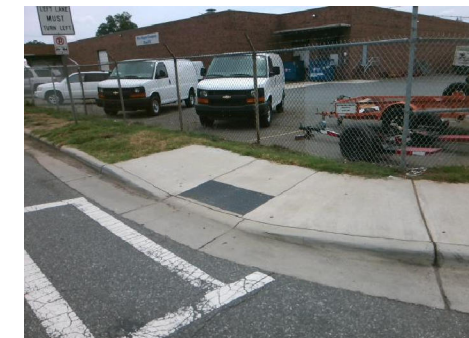
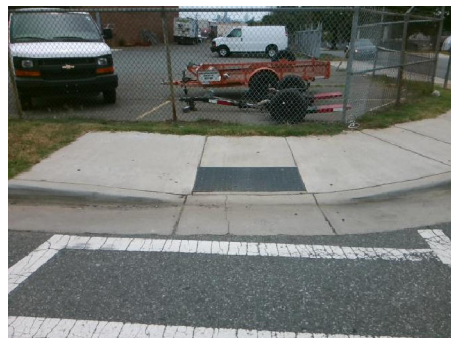
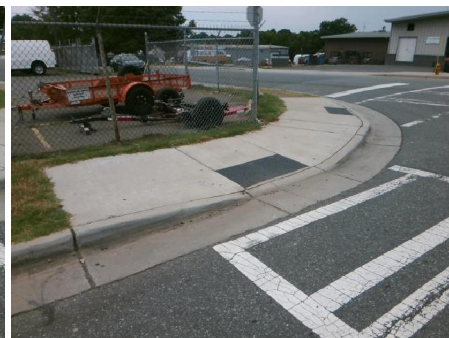
Compliance	Description	Data	Compliance	Description	Data
N/A	Ramp Length (in)	71.0	Yes	Ramp Slope (%)	6.6
No	Ramp Width (in)	47.0	Yes	Ramp XSlope (%)	1.6
N/A	Flare Type LT	N/A	N/A	Flare Type RT	N/A
N/A	Flare Slope LT (%)	N/A	N/A	Flare Slope RT (%)	N/A
N/A	Flare Traversable LT?	N/A	N/A	Flare Traversable RT?	N/A
N/A	Landing Length (in)	N/A	N/A	DWS Provided?	N/A
N/A	Landing Width (in)	N/A	N/A	DWS Contrast?	N/A
N/A	Landing Slope (%)	N/A	N/A	DWS Length (in)	N/A
N/A	Landing X Slope (%)	N/A	N/A	DWS Full Width?	N/A
N/A	Landing Curb? (Y/N)	N/A	N/A	DWS Offset (in)	N/A
N/A	Shared Landing?	N/A			
N/A	Gutter Ponding?	N/A	N/A	Gutter Slope (%)	N/A
N/A	Gutter Lip Ht (in)	N/A	N/A	Gutter X Slope (%)	N/A
N/A	Painted X Walk1?	Yes	N/A	Painted X Walk2?	N/A
	X Walk 1 Direction	To NE		X Walk 2 Direction	N/A
N/A	X Walk 1 Width (in)	114.0	N/A	X Walk 2 Width (in)	N/A
	X Walk 1 Slope (%)	6.5		X Walk 2 Slope (%)	N/A
	X Walk 1 X Slope (%)	0.2		X Walk 2 X Slope (%)	N/A

N/A	Ramp inside XWalk1?	Yes	N/A	Ramp inside XWalk2?	N/A
	Road Slope (%)	N/A	N/A	Clear Space?	N/A
	Road X Slope (%)	N/A	N/A	Clear Space to XWalk (in)	N/A
N/A	Any Obstructions?	N/A	N/A	Storm Grate/Utility Hazard?	N/A
	Obstruction Type			Storm Grate/Utility Type	
		N/A			N/A
			Yes	Surface Condition? (G/P)	Good

Possible Solutions:

Remove & Replace Entire Ramp.
