Access Compliance Report

Public Rights-of-Way

(Curb Ramps)

Intersection ID: 10655	Main Street: BELLE_PLAINE_DR	Cross Street: MILTON_RD	Location:	N
ADA ID: 73F6CB6871F1	Ramp Type: PerpDiag	Initial Pass/Fail: Fail	Overall Compliance: No	Severity Score: 18.75
Codes/Mitigation Info/Possible Solution		Field Measurements/Component Compliance

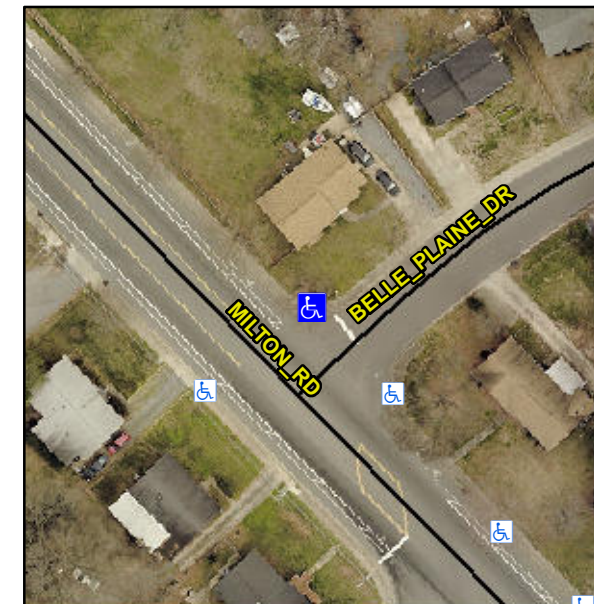
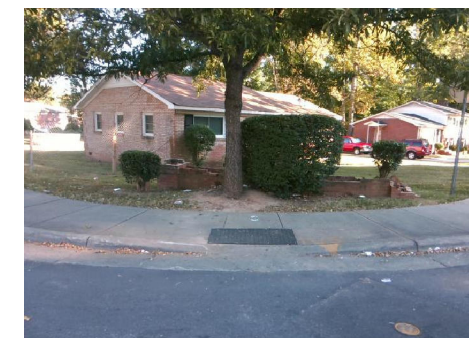
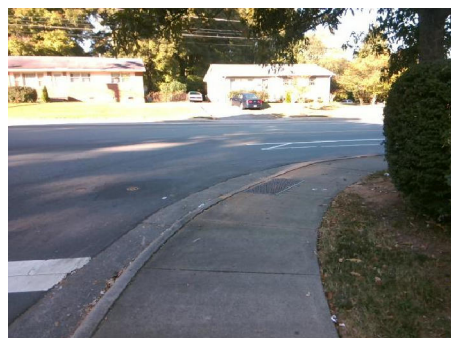
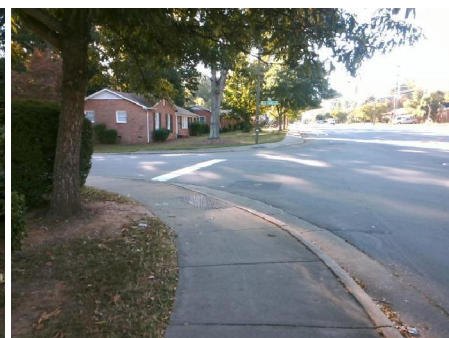
Not Found, R304.5.1, R304.5.3

Compliance	Description	Data	Compliance	Description	Data
N/A	Ramp Length (in)	59.5	Yes	Ramp Slope (%)	6.2
No	Ramp Width (in)	33.0	No	Ramp XSlope (%)	2.1
N/A	Flare Type LT	N/A	N/A	Flare Type RT	N/A
N/A	Flare Slope LT (%)	N/A	N/A	Flare Slope RT (%)	N/A
N/A	Flare Traversable LT?	N/A	N/A	Flare Traversable RT?	N/A
N/A	Landing Length (in)	N/A	N/A	DWS Provided?	N/A
N/A	Landing Width (in)	N/A	N/A	DWS Contrast?	N/A
N/A	Landing Slope (%)	N/A	N/A	DWS Length (in)	N/A
N/A	Landing X Slope (%)	N/A	N/A	DWS Full Width?	N/A
N/A	Landing Curb? (Y/N)	N/A	N/A	DWS Offset (in)	N/A
N/A	Shared Landing?	N/A			
N/A	Gutter Ponding?	N/A	N/A	Gutter Slope (%)	N/A
N/A	Gutter Lip Ht (in)	N/A	N/A	Gutter X Slope (%)	N/A
N/A	Painted X Walk1?	No	N/A	Painted X Walk2?	No
	X Walk 1 Direction	To SW		X Walk 2 Direction	To SE
N/A	X Walk 1 Width (in)	N/A	N/A	X Walk 2 Width (in)	N/A
	X Walk 1 Slope (%)	0.8		X Walk 2 Slope (%)	2.7
	X Walk 1 X Slope (%)	1.6		X Walk 2 X Slope (%)	0.3

N/A	Ramp inside XWalk1?	N/A	N/A	Ramp inside XWalk2?	N/A
	Road Slope (%)	2.8	N/A	Clear Space?	N/A
	Road X Slope (%)	1.2	N/A	Clear Space to XWalk (in)	N/A
N/A	Any Obstructions?	N/A	N/A	Storm Grate/Utility Hazard?	N/A
	Obstruction Type			Storm Grate/Utility Type	
		N/A			N/A
			Yes	Surface Condition? (G/P)	Good

Remove & Replace Curb Ramp With Two New Directional Ramps or Equivalent.
