Access Compliance Report Public Rights-of-Way (Curb Ramps)

Intersection ID: 10689 Main Street: MILTON RD Cross Street: TIPPERARY PL Location:

ADA ID: 73FCF49A66CE Ramp Type: PerpDiag Initial Pass/Fail: Fail **Overall Compliance: No Severity Score:** 8.75

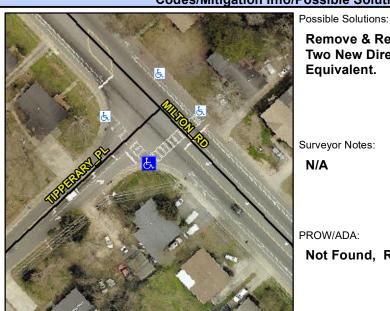
Not Found, R304.5.1

Field Measurements/Component Compliance						
Compliance Description		Data	Comp	liance	Description	Data
N/A	Ramp Length (in)	60.0	Yes	Ramp	Slope (%)	8.3
No	Ramp Width (in)	40.0	Yes	Ramp	XSlope (%)	0.5
N/A	Flare Type LT	N/A	N/A	Flare	Type RT	N/A
N/A	Flare Slope LT (%)	N/A	N/A	Flare	Slope RT (%)	N/A
N/A	Flare Traversable LT?	N/A	N/A	Flare	Traversable RT?	N/A
N/A	Landing Length (in)	N/A	N/A	DWS	Provided?	N/A
N/A	Landing Width (in)	N/A	N/A	DWS	Contrast?	N/A
N/A	Landing Slope (%)	N/A	N/A	DWS	Length (in)	N/A
N/A	Landing X Slope (%)	N/A	N/A	DWS	Full Width?	N/A
N/A	Landing Curb? (Y/N)	N/A	N/A	DWS	Offset (in)	N/A
N/A	Shared Landing?	N/A				
N/A	Gutter Ponding?	N/A	N/A	Gutte	r Slope (%)	N/A
N/A	Gutter Lip Ht (in)	N/A	N/A	Gutte	r X Slope (%)	N/A
N/A	Painted X Walk1?	Yes	N/A	Painte	ed X Walk2?	Yes
	X Walk 1 Direction	To NE		X Wa	lk 2 Direction	To NW
N/A	X Walk 1 Width (in)	121.0	N/A	X Wa	lk 2 Width (in)	108.0
	X Walk 1 Slope (%)	4.4		X Wa	lk 2 Slope (%)	3.3

X Walk 1 X Slope (%)	3.7		X Wa	lk 2 X Slope (%)	3.7
N/A	Ramp inside XWalk1?	Yes	N/A	Ramp	inside XWalk2?	Yes
	Road Slope (%)	0.4	N/A	Clear	Space?	N/A
	Road X Slope (%)	4.5	N/A	Clear	Space to XWalk (in)	N/A
N/A	Any Obstructions?	N/A	N/A	Storm	Grate/Utility Hazard?	N/A
	Obstruction Type			Storm	Grate/Utility Type	
		N/A				N/A
			Yes	Surfa	ce Condition? (G/P)	Good

MILTON RD Signal **TIPPERARY PL** Signal Remove & Replace Curb Ramp With **Two New Directional Ramps or** Equivalent.

3200.00
