# Access Compliance Report

## Public Rights-of-Way

### (Curb Ramps)

Intersection ID: 31617	Main Street: MARIA CHRISTINA LN	Cross Street: PAW CREEK RD	Location: S
ADA ID: 73FDFB42AFBA	Ramp Type: Combination1	Initial Pass/Fail: Fail	Overall Compliance: No
			Severity Score: 58.75

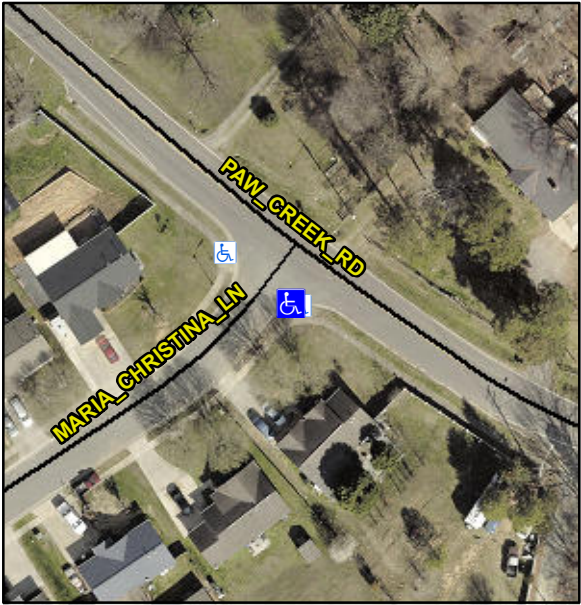
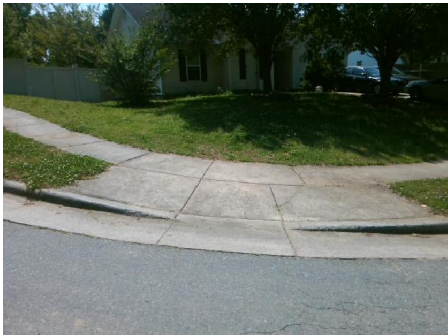
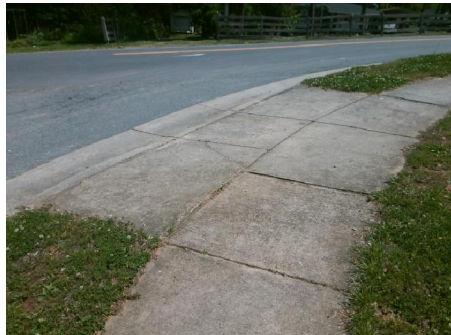
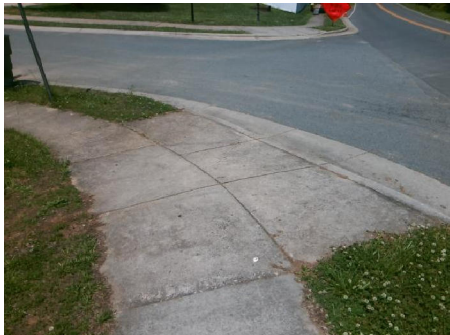
Possible Solutions:		<b>Compliance</b>	<b>Description</b>	<b>Data</b>
	<b>Remove &amp; Replace Entire Ramp.</b>		<b>N/A</b>	Ramp Length LT (in)	<b>54.0</b>
			<b>No</b>	Ramp Width LT (in)	<b>45.0</b>
			<b>No</b>	Ramp Slope LT (%)	<b>15.6</b>
			<b>No</b>	Ramp XSlope LT (%)	<b>2.8</b>
			<b>N/A</b>	Ramp Length (in)	<b>49.0</b>
			<b>No</b>	Ramp Width (in)	<b>40.0</b>
			<b>N/A</b>	Flare Type LT	<b>N/A</b>
			<b>N/A</b>	Flare Slope LT (%)	<b>N/A</b>
			<b>N/A</b>	Flare Traversable LT?	<b>N/A</b>
<p>Surveyor Notes:</p> <p><b>N/A</b></p> <p>PROW/ADA:</p> <p><b>Not Found, R304.5.1, R304.5.1, R304.2.2, R304.5.3, R304.3.2</b></p>			<b>N/A</b>	Ramp Slope RT (%)	<b>9.1</b>
			<b>No</b>	Ramp XSlope RT (%)	<b>8.9</b>
			<b>N/A</b>	Ramp Slope (%)	<b>11.3</b>
			<b>No</b>	Ramp XSlope (%)	<b>13.0</b>
			<b>N/A</b>	Flare Type RT	<b>N/A</b>

<b>N/A</b>	Flare Slope RT (%)	<b>N/A</b>
			<b>N/A</b>	Flare Traversable RT?	<b>N/A</b>
			<b>N/A</b>	DWS Provided?	<b>N/A</b>
			<b>N/A</b>	DWS Contrast?	<b>N/A</b>
			<b>N/A</b>	DWS Length (in)	<b>N/A</b>
<p>Street 1 Name</p> <p>Stop Condition-Street 1</p> <p>Street 2 Name</p> <p>Stop Condition-Street 2</p>			<b>N/A</b>	DWS Full Width?	<b>N/A</b>
			<b>N/A</b>	DWS Offset (in)	<b>N/A</b>
			<b>N/A</b>	Gutter Slope (%)	<b>N/A</b>
			<b>N/A</b>	Gutter X Slope (%)	<b>N/A</b>
			<b>N/A</b>	Painted X Walk1?	<b>N/A</b>
			<b>No</b>	Painted X Walk2?	<b>N/A</b>
			<b>To NW</b>	X Walk 2 Direction	<b>N/A</b>
			<b>N/A</b>	X Walk 2 Width (in)	<b>N/A</b>
			<b>6.6</b>	X Walk 2 Slope (%)	<b>N/A</b>
			<b>7.2</b>	X Walk 2 X Slope (%)	<b>N/A</b>
<p>Total Cost:</p> <p><b>\$ 1800.00</b></p>			<b>N/A</b>	Ramp inside XWalk1?	<b>N/A</b>
			<b>N/A</b>	Ramp inside XWalk2?	<b>N/A</b>
			<b>N/A</b>	Clear Space?	<b>N/A</b>
			<b>N/A</b>	Clear Space to XWalk (in)	<b>N/A</b>

<b>N/A</b>	Any Obstruction?	<b>N/A</b>
				Obstruction Type	<b>N/A</b>
			<b>N/A</b>	Storm Grate/Utility Hazard?	<b>N/A</b>
				Storm Grate/Utility Type	<b>N/A</b>
			<b>Yes</b>	Surface Condition? (G/P)	<b>Good</b>
				Curb Slope (%)	<b>20.7</b>
