# Access Compliance Report

## Public Rights-of-Way

### (Curb Ramps)

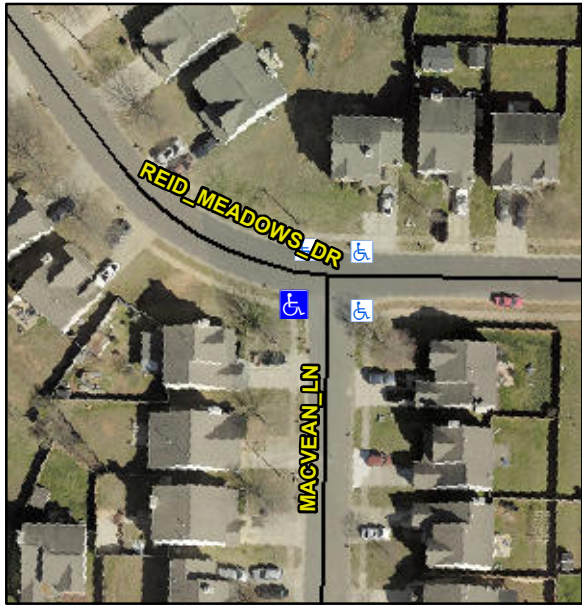
Intersection ID: 45156	Main Street: MACVEAN_LN	Cross Street: REID_MEADOWS_DR	Location: SW
ADA ID: 7407ADC4D403	Ramp Type: PerpDiag	Initial Pass/Fail: Fail	Overall Compliance: No
Severity Score: 32.5			
Codes/Mitigation Info/Possible Solution		Field Measurements/Component Compliance

Possible Solutions:							
	Remove & Replace Curb Ramp With Two New Directional Ramps or Equivalent.		N/A	Ramp Length (in)	47.0	Yes	Ramp Slope (%)	7.8
			No	Ramp Width (in)	35.0	Yes	Ramp XSlope (%)	0.6
			N/A	Flare Type LT	N/A	N/A	Flare Type RT	N/A
			N/A	Flare Slope LT (%)	N/A	N/A	Flare Slope RT (%)	N/A
			N/A	Flare Traversable LT?	N/A	N/A	Flare Traversable RT?	N/A
			N/A	Landing Length (in)	N/A	N/A	DWS Provided?	N/A
			N/A	Landing Width (in)	N/A	N/A	DWS Contrast?	N/A
			N/A	Landing Slope (%)	N/A	N/A	DWS Length (in)	N/A
			N/A	Landing X Slope (%)	N/A	N/A	DWS Full Width?	N/A
<p>Surveyor Notes:</p> <p>N/A</p> <p>PROW/ADA:</p> <p>Not Found, R304.5.1, R302.7</p>			N/A	Landing Curb? (Y/N)	N/A	N/A	DWS Offset (in)	N/A
			N/A	Shared Landing?	N/A			
			N/A	Gutter Ponding?	N/A	N/A	Gutter Slope (%)	N/A
			N/A	Gutter Lip Ht (in)	1.0	N/A	Gutter X Slope (%)	N/A
			N/A	Painted X Walk1?	No	N/A	Painted X Walk2?	No

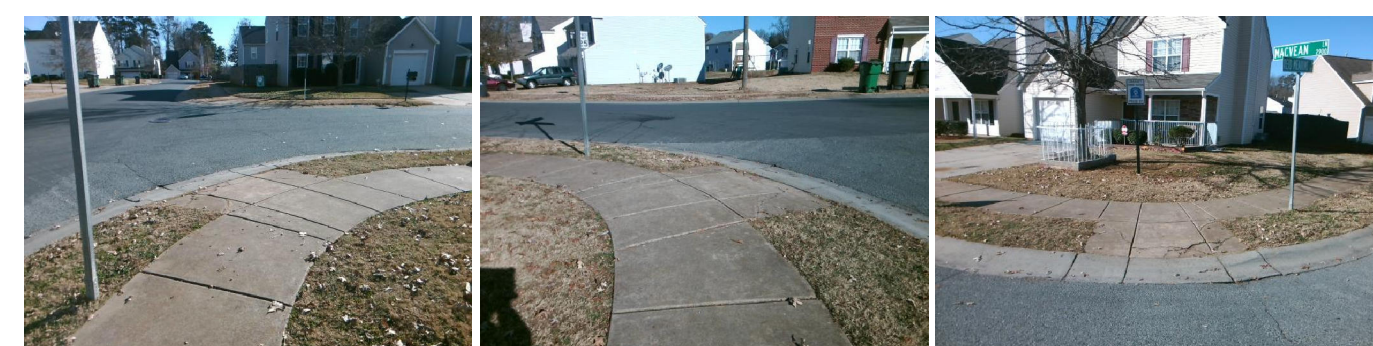
X Walk 1 Direction	To E		X Walk 2 Direction	To N
			N/A	X Walk 1 Width (in)	N/A	N/A	X Walk 2 Width (in)	N/A
				X Walk 1 Slope (%)	8.7		X Walk 2 Slope (%)	5.4
				X Walk 1 X Slope (%)	4.5		X Walk 2 X Slope (%)	6.1
			N/A	Ramp inside XWalk1?	N/A	N/A	Ramp inside XWalk2?	N/A
<p>Street 1 Name</p> <p>Stop Condition-Street 2</p> <p>Street 2 Name</p> <p>Stop Condition-Street 1</p>				Road Slope (%)	1.4	N/A	Clear Space?	N/A
				Road X Slope (%)	9.9	N/A	Clear Space to XWalk (in)	N/A
			N/A	Any Obstructions?	N/A	N/A	Storm Grate/Utility Hazard?	N/A
				Obstruction Type			Storm Grate/Utility Type	
						N/A		N/A
						No	Surface Condition? (G/P)	Poor
Total Cost:		\$	3200.00
