Access Compliance Report Public Rights-of-Way (Curb Ramps)

Intersection ID: 19528 Main Street: SOUTH_BV Cross Street: EMERYWOOD_DR Location: SE

ADA ID: 740A3897E393 Ramp Type: Perp Initial Pass/Fail: Fail Overall Compliance: No Severity Score: 22.5

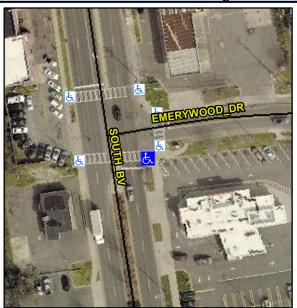
Possible Solution	Field Measurements/Component Compliance						
Possible Solutions:	Compli	ance Description	Data	Complian	ce Description	Data	
Remove & Replace Entire Ramp.	N/A	Ramp Length (in)	72.0	No R	amp Slope (%)	9.2	
	No	Ramp Width (in)	47.0	Yes Ra	amp XSlope (%)	2.6	
	N/A	Flare Type LT	N/A	N/A FI	are Type RT	N/A	
	N/A	Flare Slope LT (%)	N/A	N/A FI	are Slope RT (%)	N/A	
	N/A	Flare Traversable LT?	N/A	N/A FI	are Traversable RT?	N/A	
	N/A	Landing Length (in)	N/A	N/A D'	WS Provided?	N/A	
Surveyor Notes:	N/A	Landing Width (in)	N/A	N/A D'	WS Contrast?	N/A	
N/A	N/A	Landing Slope (%)	N/A	N/A D'	WS Length (in)	N/A	
	N/A	Landing X Slope (%)	N/A	N/A D'	WS Full Width?	N/A	
	N/A	Landing Curb? (Y/N)	N/A	N/A D'	WS Offset (in)	N/A	
	N/A	Shared Landing?	N/A				
PROW/ADA:	N/A	Gutter Ponding?	N/A	N/A G	utter Slope (%)	N/A	
Not Found, R304.5.1, R304.2.2	N/A	Gutter Lip Ht (in)	N/A	N/A G	utter X Slope (%)	N/A	
	N/A	Painted X Walk1?	Yes	N/A Pa	ainted X Walk2?	N/A
