Access Compliance Report

Public Rights-of-Way

(Curb Ramps)

Intersection ID: 52172	Main Street: BEARLING_WY	Cross Street: AVERY_MEADOWS_DR	Location: SW
ADA ID: 741A2DDE40E4	Ramp Type: Perp	Initial Pass/Fail: Fail	Overall Compliance: No
Severity Score: 1.25			
Codes/Mitigation Info/Possible Solution		Field Measurements/Component Compliance

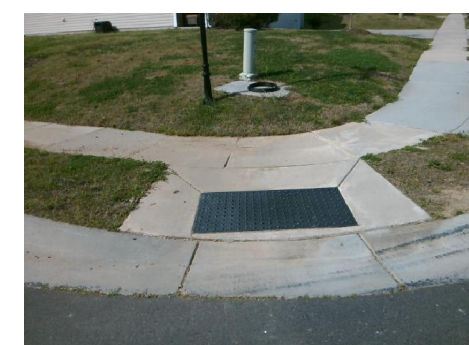
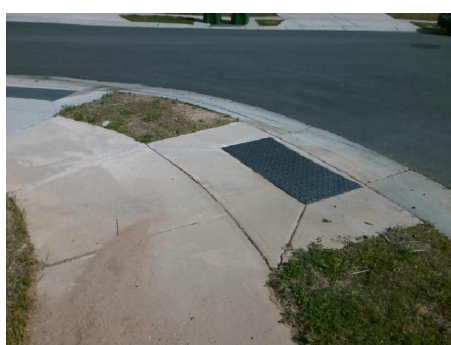
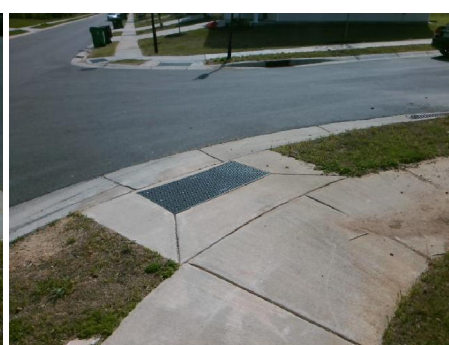
Not Found, R304.5.3

Compliance	Description	Data	Compliance	Description	Data
N/A	Ramp Length (in)	48.0	Yes	Ramp Slope (%)	8.0
Yes	Ramp Width (in)	48.0	No	Ramp XSlope (%)	2.1
N/A	Flare Type LT	N/A	N/A	Flare Type RT	N/A
N/A	Flare Slope LT (%)	N/A	N/A	Flare Slope RT (%)	N/A
N/A	Flare Traversable LT?	N/A	N/A	Flare Traversable RT?	N/A
N/A	Landing Length (in)	N/A	N/A	DWS Provided?	N/A
N/A	Landing Width (in)	N/A	N/A	DWS Contrast?	N/A
N/A	Landing Slope (%)	N/A	N/A	DWS Length (in)	N/A
N/A	Landing X Slope (%)	N/A	N/A	DWS Full Width?	N/A
N/A	Landing Curb? (Y/N)	N/A	N/A	DWS Offset (in)	N/A
N/A	Shared Landing?	N/A			
N/A	Gutter Ponding?	N/A	N/A	Gutter Slope (%)	N/A
N/A	Gutter Lip Ht (in)	N/A	N/A	Gutter X Slope (%)	N/A
N/A	Painted X Walk1?	No	N/A	Painted X Walk2?	N/A
	X Walk 1 Direction	To E		X Walk 2 Direction	N/A
N/A	X Walk 1 Width (in)	N/A	N/A	X Walk 2 Width (in)	N/A
	X Walk 1 Slope (%)	3.7		X Walk 2 Slope (%)	N/A
	X Walk 1 X Slope (%)	0.5		X Walk 2 X Slope (%)	N/A

N/A	Ramp inside XWalk1?	N/A	N/A	Ramp inside XWalk2?	N/A
	Road Slope (%)	N/A	N/A	Clear Space?	N/A
	Road X Slope (%)	N/A	N/A	Clear Space to XWalk (in)	N/A
N/A	Any Obstructions?	N/A	N/A	Storm Grate/Utility Hazard?	N/A
	Obstruction Type			Storm Grate/Utility Type	
		N/A			N/A
			Yes	Surface Condition? (G/P)	Good

Possible Solutions:

Remove & Replace Entire Ramp.

Total Cost: \$ 1850.00
