Access Compliance Report

Public Rights-of-Way

(Curb Ramps)

Intersection ID: N/A	Main Street: KENSAL_GREEN_DR	Cross Street: WILTSHIRE_MANOR_DR	Location: N
ADA ID: 74219C450AE3	Ramp Type: Directional1	Initial Pass/Fail: Fail	Overall Compliance: No
		Severity Score: 10

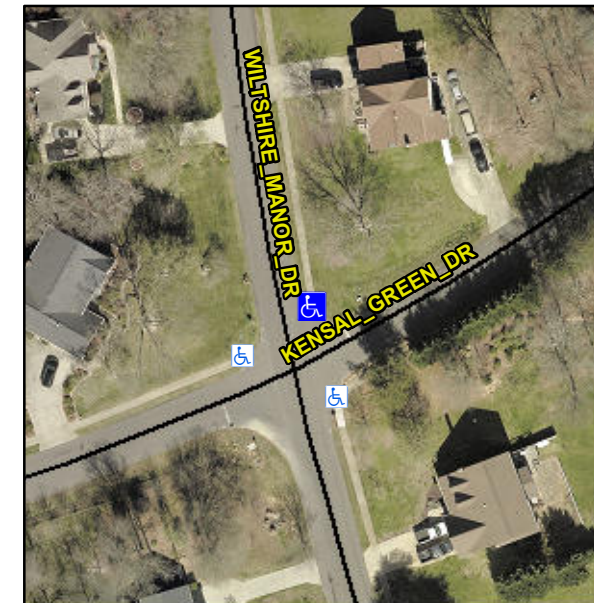
Compliance	Description	Data	Compliance	Description	Data
N/A	Ramp Length (in)	66.0	N/A	Grade Break?	N/A
No	Ramp Width (in)	47.0	N/A	Grade Break Slope (%)	0.0
Yes	Ramp Slope (%)	0.0	N/A	Grade Break XSlope (%)	0.0
No	Ramp XSlope (%)	2.1			
N/A	Flare Type LT	N/A	N/A	Flare Type RT	N/A
N/A	Flare Slope LT (%)	N/A	N/A	Flare Slope RT (%)	0.0
N/A	Flare Traversable LT?	N/A	N/A	Flare Traversable RT?	N/A
N/A	Landing Length (in)	0.0	N/A	DWS Provided?	N/A
N/A	Landing Width (in)	0.0	N/A	DWS Contrast?	N/A
N/A	Landing Slope (%)	0.0	N/A	DWS Length (in)	N/A
N/A	Landing X Slope (%)	0.0	N/A	DWS Full Width?	N/A
N/A	Landing Curb? (Y/N)	N/A	N/A	DWS Offset LT (in)	N/A
N/A	Shared Landing?	N/A	N/A	DWS Offset RT (in)	N/A
N/A	Gutter Ponding?	0.0	N/A	Gutter Slope (%)	N/A
N/A	Gutter Lip Ht (in)	0.0	N/A	Gutter X Slope (%)	N/A
N/A	Painted X Walk1?	No		Road Slope (%)	3.5
	X Walk 1 Direction	To SE		Road X Slope (%)	4.6
	X Walk 1 Width (in)	N/A		Clear Space?	N/A

X Walk 1 Slope (%)	3.5	N/A	Clear Space to XWalk (in)	N/A
	X Walk 1 X Slope (%)	4.6	N/A	Storm Grate/Utility Hazard?	N/A
N/A	Ramp inside XWalk1?	N/A		Storm Grate/Utility Type	
N/A	Any Obstructions?	N/A			N/A
	Obstruction Type		Yes	Surface Condition? (G/P)	Good
			N/A	Curb Slope (%)	5.7

Remove & Replace Entire Ramp.
