## **Access Compliance Report Public Rights-of-Way** (Curb Ramps)

**Cross Street: LONGSTRAW RD** Intersection ID: 50591 Main Street: GREEN GRASS RD Location: NE **Overall Compliance: No** ADA ID: 74223F063677 Ramp Type: Perp Initial Pass/Fail: Fail **Severity Score:** 8.75

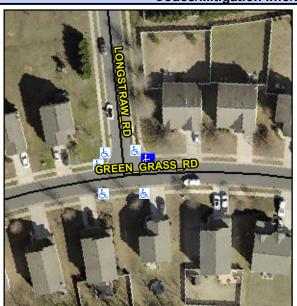
**GREEN GRASS RD** Street 1 Name Stop Condition-Street 2 None Street 2 Name N/A Stop Condition-Street 1 N/A

-	Possible Solutions:
	Remove & Replace Entire Ramp.
3	
	Surveyor Notes:
1	N/A
-	PROW/ADA:
	R304.5.1
1	
A STATE	
_
