Access Compliance Report

Public Rights-of-Way

(Curb Ramps)

| Intersection ID: N/A | Main Street: E_STONEWALL_ST | Cross Street: S_MCDOWELL_ST | Location: SE |

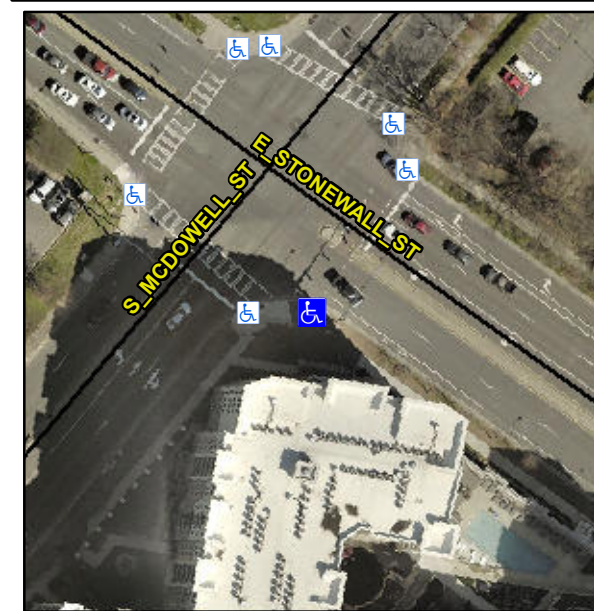
Not Found, R304.2.2-Perp, R304.3.2-Para, R305.2

| Compliance | Description | Data | Compliance | Description | Data |
|---|---|---|---|---|---|
| No | Landing Slope (%) | 2.5 | Yes | DWS Length (in) | 24.0 |
| N/A | Landing Curb? (Y/N) | No | No | DWS Offset (in) | 3.5 |

Possible Solutions:

Remove & Replace Entire Ramp.

Total Cost: \$ 1850.00
