Access Compliance Report

Public Rights-of-Way

(Curb Ramps)

Intersection ID: 12182	Main Street: BRYANT_ST	Cross Street: S_SUMMIT_AV	Location: NW
ADA ID: 742715A495AD	Ramp Type: BlendTrans1	Initial Pass/Fail: Fail	Overall Compliance: No
		Severity Score: 1.25

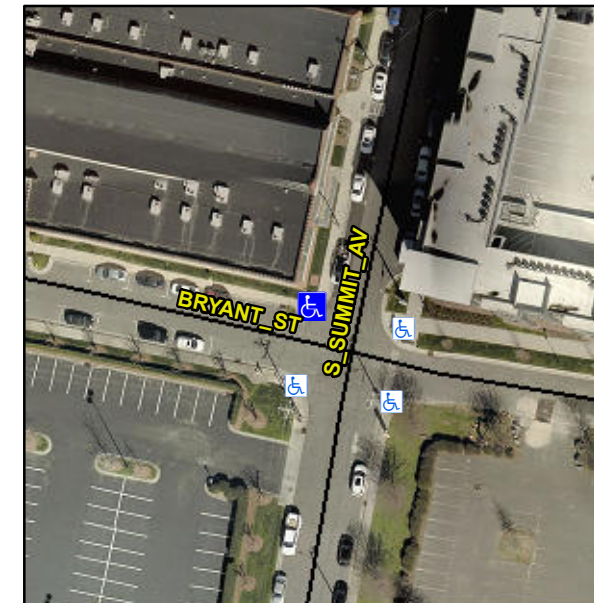
Compliance	Description	Data	Compliance	Description	Data
N/A	Ramp Length (in)	60.0	Yes	BlendTrans Slope (%)	2.4
Yes	Ramp Width (in)	48.0	No	BlendTrans XSlope (%)	2.3
N/A	Flare Type LT	N/A	N/A	Flare Type RT	N/A
N/A	Flare Slope LT (%)	N/A	N/A	Flare Slope RT (%)	N/A
N/A	Flare Traversable LT?	N/A	N/A	Flare Traversable RT?	N/A
N/A	Landing Length (in)	N/A	N/A	DWS Provided?	N/A
N/A	Landing Width (in)	N/A	N/A	DWS Contrast?	N/A
N/A	Landing Slope (%)	N/A	N/A	DWS Length (in)	N/A
N/A	Landing X Slope (%)	N/A	N/A	DWS Full Width?	N/A
N/A	Landing Curb? (Y/N)	N/A	N/A	DWS Offset (in)	N/A
N/A	Shared Landing?	N/A			
N/A	Gutter Ponding?	N/A	N/A	Gutter Slope (%)	N/A
N/A	Gutter Lip Ht (in)	N/A	N/A	Gutter X Slope (%)	N/A
N/A	Painted X Walk1?	No	N/A	Painted X Walk2?	No
	X Walk 1 Direction	To S		X Walk 2 Direction	To E
	X Walk 1 Width (in)	N/A		X Walk 2 Width (in)	N/A
	X Walk 1 Slope (%)	2.9		X Walk 2 Slope (%)	2.5
	X Walk 1 X Slope (%)	0.3		X Walk 2 X Slope (%)	1.2

N/A	Ramp inside XWalk1?	N/A	N/A	Ramp inside XWalk2?	N/A
	Road Slope (%)	1.0		Clear Space?	N/A
	Road X Slope (%)	2.3	N/A	Clear Space to XWalk (in)	N/A
N/A	Any Obstructions?	N/A	N/A	Storm Grate/Utility Hazard?	N/A
	Obstruction Type			Storm Grate/Utility Type	
		N/A			N/A
			Yes	Surface Condition? (G/P)	Good
			N/A	Curb Slope (%)	N/A

Remove & Replace Curb Ramp With Two New Directional Ramps or Equivalent.

R304.5.3

\$ 3200.00

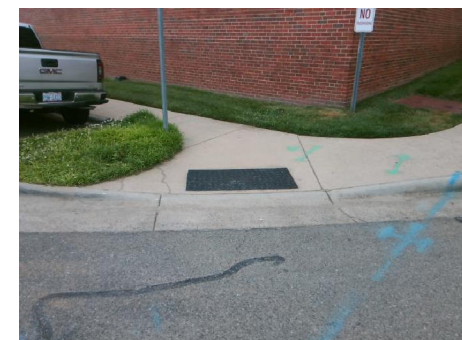
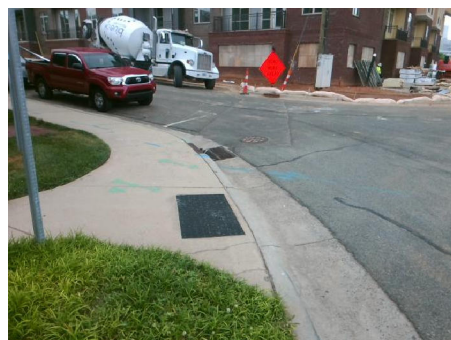
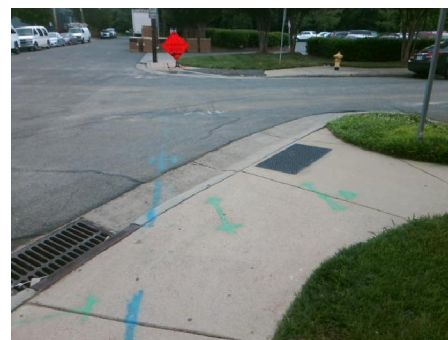
Street 1 Name **BRYANT ST**
 Stop Condition-Street 1 **StopSign**
 Street 2 Name **S SUMMIT AV**
 Stop Condition-Street 2 **None**
