Access Compliance Report

Public Rights-of-Way

(Curb Ramps)

Intersection ID: 17176	Main Street: BURNTWOOD_CT	Cross Street: MISSION_HILLS_RD	Location: NE
ADA ID: 7427937122D8	Ramp Type: BlendTrans1	Initial Pass/Fail: Fail	Overall Compliance: No
Severity Score: 10			
Codes/Mitigation Info/Possible Solution		Field Measurements/Component Compliance

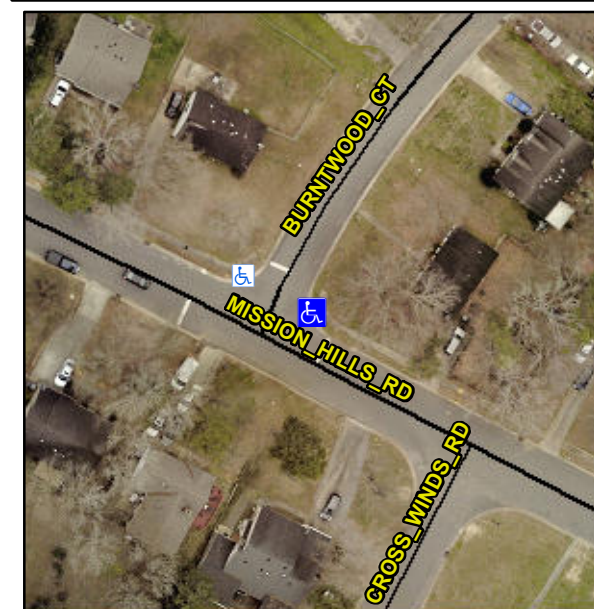
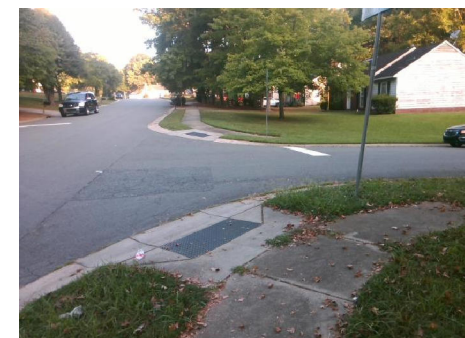
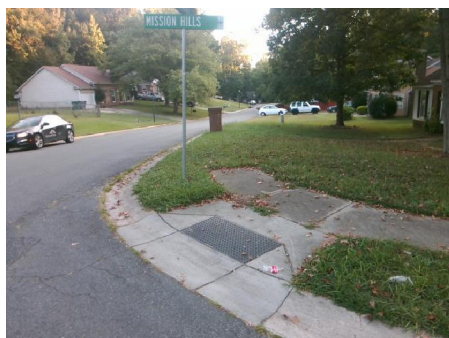
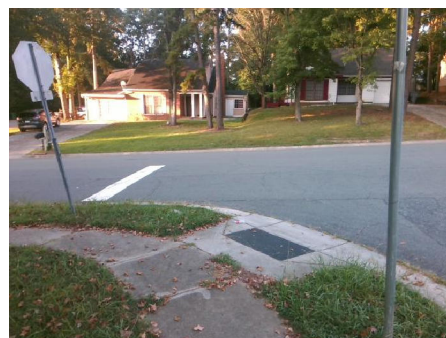
Not Found, R304.5.1, R304.5.3

Compliance	Description	Data	Compliance	Description	Data
N/A	Ramp Length (in)	46.5	Yes	BlendTrans Slope (%)	4.1
No	Ramp Width (in)	47.5	No	BlendTrans XSlope (%)	2.6
N/A	Flare Type LT	N/A	N/A	Flare Type RT	N/A
N/A	Flare Slope LT (%)	N/A	N/A	Flare Slope RT (%)	N/A
N/A	Flare Traversable LT?	N/A	N/A	Flare Traversable RT?	N/A
N/A	Landing Length (in)	N/A	N/A	DWS Provided?	N/A
N/A	Landing Width (in)	N/A	N/A	DWS Contrast?	N/A
N/A	Landing Slope (%)	N/A	N/A	DWS Length (in)	N/A
N/A	Landing X Slope (%)	N/A	N/A	DWS Full Width?	N/A
N/A	Landing Curb? (Y/N)	N/A	N/A	DWS Offset (in)	N/A
N/A	Shared Landing?	N/A			
N/A	Gutter Ponding?	N/A	N/A	Gutter Slope (%)	N/A
N/A	Gutter Lip Ht (in)	N/A	N/A	Gutter X Slope (%)	N/A
N/A	Painted X Walk1?	No	N/A	Painted X Walk2?	No
	X Walk 1 Direction	To NW		X Walk 2 Direction	To SW
	X Walk 1 Width (in)	N/A		X Walk 2 Width (in)	N/A
	X Walk 1 Slope (%)	3.2		X Walk 2 Slope (%)	1.4
	X Walk 1 X Slope (%)	1.2		X Walk 2 X Slope (%)	4.4

N/A	Ramp inside XWalk1?	N/A	N/A	Ramp inside XWalk2?	N/A
	Road Slope (%)	2.9		Clear Space?	N/A
	Road X Slope (%)	2.9	N/A	Clear Space to XWalk (in)	N/A
N/A	Any Obstructions?	N/A	N/A	Storm Grate/Utility Hazard?	N/A
	Obstruction Type			Storm Grate/Utility Type	
		N/A			N/A
			Yes	Surface Condition? (G/P)	Good
			No	Curb Slope (%)	12.6

Possible Solutions:

Remove & Replace Curb Ramp With Two New Directional Ramps or Equivalent.
