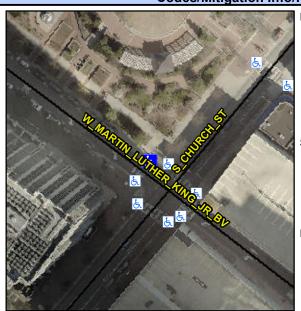
Intersection ID: 12431Main Street: S\_CHURCH\_STCross Street: W\_MARTIN\_LUTHER\_KING\_JR\_BVLocation:NADA ID: 74332F82A1BERamp Type: PerpInitial Pass/Fail: FailOverall Compliance: NoSeverity Score:25

Field Measurements/Component Compliance						
Compliance Description		Data	Comp	liance Description	Data	
N/A	Ramp Length (in)	112.0	No	Ramp Slope (%)	13.1	
Yes	Ramp Width (in)	48.2	Yes	Ramp XSlope (%)	1.3	
N/A	Flare Type LT	N/A	N/A	Flare Type RT	N/A	
N/A	Flare Slope LT (%)	N/A	N/A	Flare Slope RT (%)	N/A	
N/A	Flare Traversable LT?	N/A	N/A	Flare Traversable RT?	N/A	
N/A	Landing Length (in)	N/A	N/A	DWS Provided?	N/A	
N/A	Landing Width (in)	N/A	N/A	DWS Contrast?	N/A	
N/A	Landing Slope (%)	N/A	N/A	DWS Length (in)	N/A	
N/A	Landing X Slope (%)	N/A	N/A	DWS Full Width?	N/A	
N/A	Landing Curb? (Y/N)	N/A	N/A	DWS Offset (in)	N/A	
N/A	Shared Landing?	N/A				
N/A	Gutter Ponding?	N/A	N/A	Gutter Slope (%)	N/A	
N/A	Gutter Lip Ht (in)	N/A	N/A	Gutter X Slope (%)	N/A	
N/A	Painted X Walk1?	Yes	N/A	Painted X Walk2?	N/A	
	X Walk 1 Direction	To SW		X Walk 2 Direction	N/A	
N/A	X Walk 1 Width (in)	113.0	N/A	X Walk 2 Width (in)	N/A

X Walk 1 Slope (%)	0.0		X Walk 2 Slope (%)	N/A	
	X Walk 1 X Slope (%)	0.3		X Walk 2 X Slope (%)	N/A	
N/A	Ramp inside XWalk1?	Yes	N/A	Ramp inside XWalk2?	N/A	
	Road Slope (%)	N/A	N/A	Clear Space?	N/A	
	Road X Slope (%)	N/A	N/A	Clear Space to XWalk (in)	N/A	
N/A	Any Obstructions?	N/A	N/A	Storm Grate/Utility Hazard?	N/A	
	Obstruction Type			Storm Grate/Utility Type		
		N/A			N/A	
			Yes	Surface Condition? (G/P)	Good

rossible Solution
Possible Solutions:
Remove & Replace Entire Ramp.
Surveyor Notes:
N/A
PROW/ADA:
R304.2.2
