Access Compliance Report

Public Rights-of-Way

(Curb Ramps)

Intersection ID: 19986	Main Street: ARCHDALE_DR	Cross Street: SOUTH_BV	Location: NE
ADA ID: 743ECFF5500F	Ramp Type: Perp	Initial Pass/Fail: Fail	Overall Compliance: No
Severity Score: 22.5			
Codes/Mitigation Info/Possible Solution		Field Measurements/Component Compliance

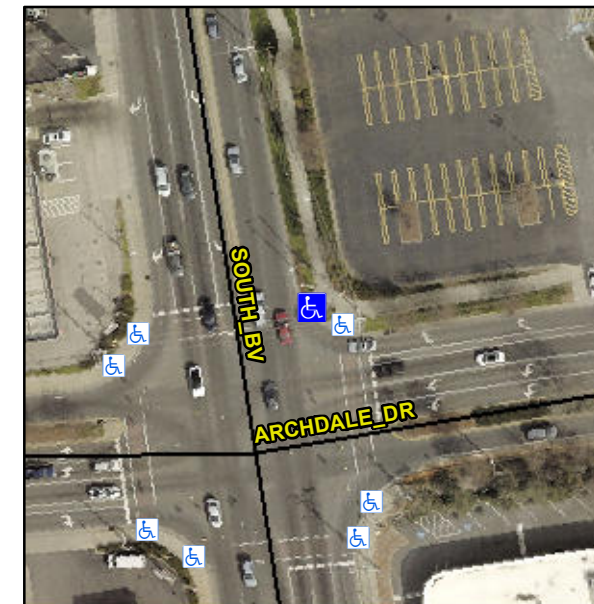
Not Found, R304.5.1, R304.2.2, R304.5.3

Compliance	Description	Data	Compliance	Description	Data
N/A	Ramp Length (in)	96.0	No	Ramp Slope (%)	9.0
No	Ramp Width (in)	46.5	No	Ramp XSlope (%)	2.3
N/A	Flare Type LT	N/A	N/A	Flare Type RT	N/A
N/A	Flare Slope LT (%)	N/A	N/A	Flare Slope RT (%)	N/A
N/A	Flare Traversable LT?	N/A	N/A	Flare Traversable RT?	N/A
N/A	Landing Length (in)	N/A	N/A	DWS Provided?	N/A
N/A	Landing Width (in)	N/A	N/A	DWS Contrast?	N/A
N/A	Landing Slope (%)	N/A	N/A	DWS Length (in)	N/A
N/A	Landing X Slope (%)	N/A	N/A	DWS Full Width?	N/A
N/A	Landing Curb? (Y/N)	N/A	N/A	DWS Offset (in)	N/A
N/A	Shared Landing?	N/A			
N/A	Gutter Ponding?	N/A	N/A	Gutter Slope (%)	N/A
N/A	Gutter Lip Ht (in)	N/A	N/A	Gutter X Slope (%)	N/A
N/A	Painted X Walk1?	Yes	N/A	Painted X Walk2?	N/A
	X Walk 1 Direction	To W		X Walk 2 Direction	N/A
N/A	X Walk 1 Width (in)	108.0	N/A	X Walk 2 Width (in)	N/A
	X Walk 1 Slope (%)	4.1		X Walk 2 Slope (%)	N/A
	X Walk 1 X Slope (%)	0.0		X Walk 2 X Slope (%)	N/A

N/A	Ramp inside XWalk1?	Yes	N/A	Ramp inside XWalk2?	N/A
	Road Slope (%)	N/A	N/A	Clear Space?	N/A
	Road X Slope (%)	N/A	N/A	Clear Space to XWalk (in)	N/A
N/A	Any Obstructions?	N/A	N/A	Storm Grate/Utility Hazard?	N/A
	Obstruction Type			Storm Grate/Utility Type	
		N/A			N/A
		Yes		Surface Condition? (G/P)	Good

Remove & Replace Entire Ramp.
