Surface Condition? (G/P)

Intersection ID: 13546 Main Street: N_SHARON_AMITY_RD Cross Street: TARRYWOOD_LN Location: N

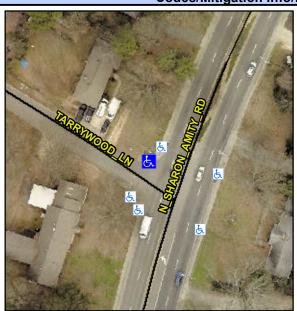
Total Cost: \$ 1850.00

ricia incusarcinients/component compilance						
Compliance Description		Data	Compliance Description		Data	
N/A	Ramp Length (in)	60.5	No	Ramp Slope (%)	9.1	
No	Ramp Width (in)	45.0	No	Ramp XSlope (%)	3.8	
N/A	Flare Type LT	N/A	N/A	Flare Type RT	N/A	
N/A	Flare Slope LT (%)	N/A	N/A	Flare Slope RT (%)	N/A	
N/A	Flare Traversable LT?	N/A	N/A	Flare Traversable RT?	N/A	
N/A	Landing Length (in)	N/A	N/A	DWS Provided?	N/A	
N/A	Landing Width (in)	N/A	N/A	DWS Contrast?	N/A	
N/A	Landing Slope (%)	N/A	N/A	DWS Length (in)	N/A	
N/A	Landing X Slope (%)	N/A	N/A	DWS Full Width?	N/A	
N/A	Landing Curb? (Y/N)	N/A	N/A	DWS Offset (in)	N/A	
N/A	Shared Landing?	N/A				
N/A	Gutter Ponding?	N/A	N/A	Gutter Slope (%)	N/A	
N/A	Gutter Lip Ht (in)	2.0	N/A	Gutter X Slope (%)	N/A	
N/A	Painted X Walk1?	No	N/A	Painted X Walk2?	N/A	
	X Walk 1 Direction	To SW		X Walk 2 Direction	N/A	
N/A	X Walk 1 Width (in)	N/A	N/A	X Walk 2 Width (in)	N/A	
	X Walk 1 Slope (%)	1.2		X Walk 2 Slope (%)	N/A

Possible Solutions:

PROW/ADA:
