# Access Compliance Report

## Public Rights-of-Way

### (Curb Ramps)

Intersection ID: 5833	Main Street: GUM_BRANCH_RD	Cross Street: KENTBERRY_DR	Location: W
ADA ID: 7447D6AFBE8D	Ramp Type: Directional1	Initial Pass/Fail: Pass	Overall Compliance: No
Severity Score: 2.5			
Codes/Mitigation Info/Possible Solution		Field Measurements/Component Compliance

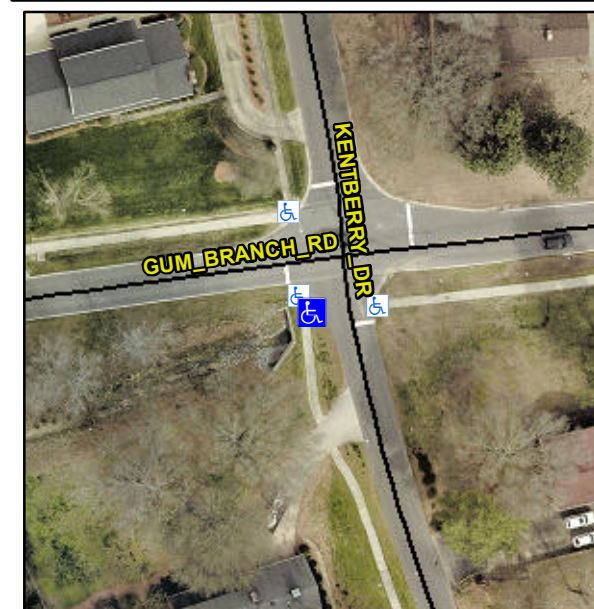
Compliance	Description	Data	Compliance	Description	Data
N/A	Ramp Length (in)	49.5	Yes	Grade Break?	Yes
Yes	Ramp Width (in)	60.0	Yes	Grade Break Slope (%)	2.2
Yes	Ramp Slope (%)	1.5	Yes	Grade Break XSlope (%)	0.2
Yes	Ramp XSlope (%)	1.3			
N/A	Flare Type LT	N/A	N/A	Flare Type RT	N/A
N/A	Flare Slope LT (%)	N/A	N/A	Flare Slope RT (%)	N/A
N/A	Flare Traversable LT?	N/A	N/A	Flare Traversable RT?	N/A
Yes	Landing Length (in)	58.5	Yes	DWS Provided?	Yes
Yes	Landing Width (in)	58.0	Yes	DWS Contrast?	Yes
Yes	Landing Slope (%)	0.9	Yes	DWS Length (in)	24.5
Yes	Landing X Slope (%)	0.4	No	DWS Full Width?	No
N/A	Landing Curb? (Y/N)	No	Yes	DWS Offset LT (in)	24.5
N/A	Shared Landing?	Yes	No	DWS Offset RT (in)	4.0
Yes	Gutter Ponding?	No	Yes	Gutter Slope (%)	1.8
Yes	Gutter Lip Ht (in)	0.0	Yes	Gutter X Slope (%)	0.6
N/A	Painted X Walk1?	No		Road Slope (%)	4.5
	X Walk 1 Direction	To E		Road X Slope (%)	0.4
	X Walk 1 Width (in)	N/A		Clear Space?	Yes

X Walk 1 Slope (%)	4.5	N/A	Clear Space to XWalk (in)	N/A
	X Walk 1 X Slope (%)	0.4	Yes	Storm Grate/Utility Hazard?	No
N/A	Ramp inside XWalk1?	N/A		Storm Grate/Utility Type	
Yes	Any Obstructions?	No			N/A
	Obstruction Type		Yes	Surface Condition? (G/P)	Good
			N/A	Curb Slope (%)	0.1

Possible Solutions:

**Remove & Replace Detectable Warning System.**

PROW/ADA:

**R305.1.4, R305.2**
