Access Compliance Report

Public Rights-of-Way

(Curb Ramps)

Intersection ID: 19432	Main Street: REXFORD_RD	Cross Street: COCA-COLA PLAZA	Location: SW
ADA ID: 744BA4EF0E01	Ramp Type: Perp	Initial Pass/Fail: Fail	Overall Compliance: No
		Severity Score: 27.5

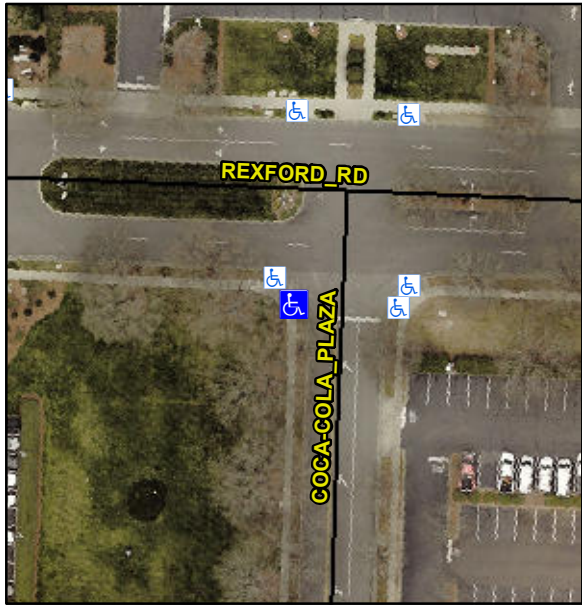
Possible Solutions:		Compliance			Description			Data		
	Remove & Replace Entire Ramp.		N/A	Ramp Length (in)		122.0	Yes	Ramp Slope (%)		5.4	
			Yes	Ramp Width (in)		48.0	No	Ramp XSlope (%)		5.1	
			N/A	Flare Type LT		N/A	N/A	Flare Type RT		N/A	
			N/A	Flare Slope LT (%)		N/A	N/A	Flare Slope RT (%)		N/A	
			N/A	Flare Traversable LT?		N/A	N/A	Flare Traversable RT?		N/A	
			N/A	Landing Length (in)		N/A	N/A	DWS Provided?		N/A	
			N/A	Landing Width (in)		N/A	N/A	DWS Contrast?		N/A	
			N/A	Landing Slope (%)		N/A	N/A	DWS Length (in)		N/A	
			N/A	Landing X Slope (%)		N/A	N/A	DWS Full Width?		N/A	
		N/A	Landing Curb? (Y/N)		N/A	N/A	DWS Offset (in)		N/A		
		N/A	Shared Landing?		N/A						
		N/A	Gutter Ponding?		N/A	N/A	Gutter Slope (%)		N/A		
		N/A	Gutter Lip Ht (in)		N/A	N/A	Gutter X Slope (%)		N/A		
		N/A	Painted X Walk1?		No	N/A	Painted X Walk2?		N/A

X Walk 1 Direction		To E		X Walk 2 Direction		N/A		
		N/A	X Walk 1 Width (in)		N/A	N/A	X Walk 2 Width (in)		N/A		
			X Walk 1 Slope (%)		2.2		X Walk 2 Slope (%)		N/A		
			X Walk 1 X Slope (%)		2.9		X Walk 2 X Slope (%)		N/A		
		N/A	Ramp inside XWalk1?		N/A	N/A	Ramp inside XWalk2?		N/A		
			Road Slope (%)		N/A	N/A	Clear Space?		N/A		
			Road X Slope (%)		N/A	N/A	Clear Space to XWalk (in)		N/A		
		N/A	Any Obstructions?		N/A	N/A	Storm Grate/Utility Hazard?		N/A		
			Obstruction Type				Storm Grate/Utility Type				
						N/A			N/A		
						No	Surface Condition? (G/P)		Poor
