# Access Compliance Report

## Public Rights-of-Way

### (Curb Ramps)

Intersection ID: 47136	Main Street: DARLINGTON_RD	Cross Street: HABITAT_MANOR_DR	Location: NE
ADA ID: 744D72328C7E	Ramp Type: PerpDiag	Initial Pass/Fail: Fail	Overall Compliance: No
Severity Score: 21.25			
Codes/Mitigation Info/Possible Solution		Field Measurements/Component Compliance

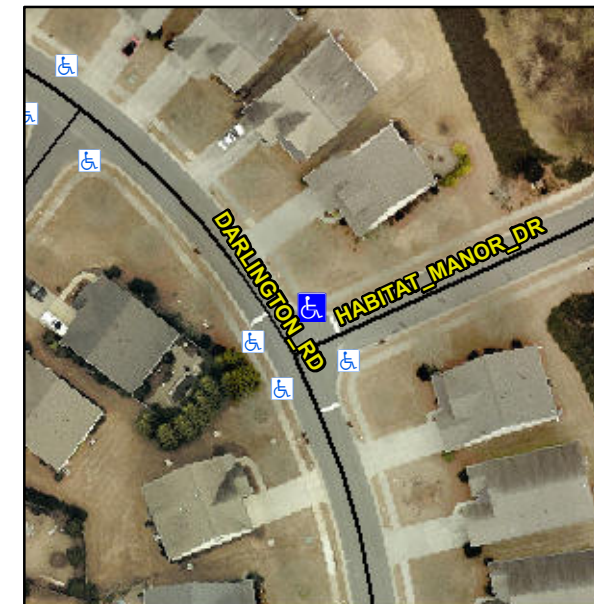
**Not Found, R304.5.1, R304.5.3**

Compliance	Description	Data	Compliance	Description	Data
N/A	Ramp Length (in)	48.0	Yes	Ramp Slope (%)	7.2
No	Ramp Width (in)	36.0	No	Ramp XSlope (%)	6.2
N/A	Flare Type LT	N/A	N/A	Flare Type RT	N/A
N/A	Flare Slope LT (%)	N/A	N/A	Flare Slope RT (%)	N/A
N/A	Flare Traversable LT?	N/A	N/A	Flare Traversable RT?	N/A
N/A	Landing Length (in)	N/A	N/A	DWS Provided?	N/A
N/A	Landing Width (in)	N/A	N/A	DWS Contrast?	N/A
N/A	Landing Slope (%)	N/A	N/A	DWS Length (in)	N/A
N/A	Landing X Slope (%)	N/A	N/A	DWS Full Width?	N/A
N/A	Landing Curb? (Y/N)	N/A	N/A	DWS Offset (in)	N/A
N/A	Shared Landing?	N/A			
N/A	Gutter Ponding?	N/A	N/A	Gutter Slope (%)	N/A
N/A	Gutter Lip Ht (in)	N/A	N/A	Gutter X Slope (%)	N/A
N/A	Painted X Walk1?	No	N/A	Painted X Walk2?	No
	X Walk 1 Direction	To W		X Walk 2 Direction	To S
N/A	X Walk 1 Width (in)	N/A	N/A	X Walk 2 Width (in)	N/A
	X Walk 1 Slope (%)	5.3		X Walk 2 Slope (%)	0.4
	X Walk 1 X Slope (%)	1.7		X Walk 2 X Slope (%)	6.4

N/A	Ramp inside XWalk1?	N/A	N/A	Ramp inside XWalk2?	N/A
	Road Slope (%)	6.1	N/A	Clear Space?	N/A
	Road X Slope (%)	3.0	N/A	Clear Space to XWalk (in)	N/A
N/A	Any Obstructions?	N/A	N/A	Storm Grate/Utility Hazard?	N/A
	Obstruction Type			Storm Grate/Utility Type	
		N/A			N/A
		Yes		Surface Condition? (G/P)	Good

**Remove & Replace Curb Ramp With Two New Directional Ramps or Equivalent.**

Total Cost: \$ 3200.00
