Access Compliance Report Public Rights-of-Way (Curb Ramps)

Intersection ID: 54156 Main Street: OAKDALE RIDGE RD Cross Street: MAPLE CREEK CT Location: SW

ADA ID: 744FE3F796B1 Ramp Type: Perp Initial Pass/Fail: Fail Overall Compliance: No Severity Score: 8.75

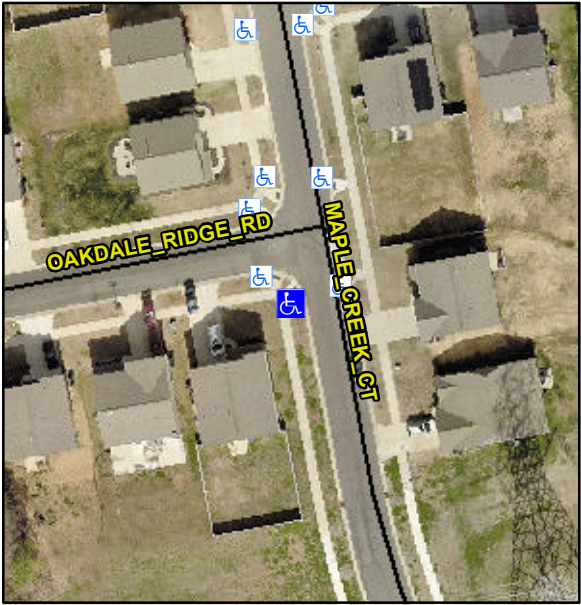
PROW/ADA:
R304.5.1

Compliance	Description	Data	Compliance	Description	Data
N/A	Ramp Length (in)	96.0	Yes	Ramp Slope (%)	6.8
No	Ramp Width (in)	46.0	Yes	Ramp XSlope (%)	0.3
N/A	Flare Type LT	N/A	N/A	Flare Type RT	N/A
N/A	Flare Slope LT (%)	N/A	N/A	Flare Slope RT (%)	N/A
N/A	Flare Traversable LT?	N/A	N/A	Flare Traversable RT?	N/A
N/A	Landing Length (in)	N/A	N/A	DWS Provided?	N/A
N/A	Landing Width (in)	N/A	N/A	DWS Contrast?	N/A
N/A	Landing Slope (%)	N/A	N/A	DWS Length (in)	N/A
N/A	Landing X Slope (%)	N/A	N/A	DWS Full Width?	N/A
N/A	Landing Curb? (Y/N)	N/A	N/A	DWS Offset (in)	N/A
N/A	Shared Landing?	N/A			
N/A	Gutter Ponding?	N/A	N/A	Gutter Slope (%)	N/A
N/A	Gutter Lip Ht (in)	1.0	N/A	Gutter X Slope (%)	N/A
N/A	Painted X Walk1?	No	N/A	Painted X Walk2?	N/A
	X Walk 1 Direction	To E		X Walk 2 Direction	N/A
N/A	X Walk 1 Width (in)	N/A	N/A	X Walk 2 Width (in)	N/A
	X Walk 1 Slope (%)	2.6		X Walk 2 Slope (%)	N/A
	X Walk 1 X Slope (%)	2.5		X Walk 2 X Slope (%)	N/A

N/A	Ramp inside XWalk1?	N/A	N/A	Ramp inside XWalk2?	N/A
	Road Slope (%)	N/A	N/A	Clear Space?	N/A
	Road X Slope (%)	N/A	N/A	Clear Space to XWalk (in)	N/A
N/A	Any Obstructions?	N/A	N/A	Storm Grate/Utility Hazard?	N/A
	Obstruction Type			Storm Grate/Utility Type	
			N/A		N/A
			Yes	Surface Condition? (G/P)	Good

Possible Solutions:
Remove & Replace Entire Ramp.

Total Cost: \$ 1850.00

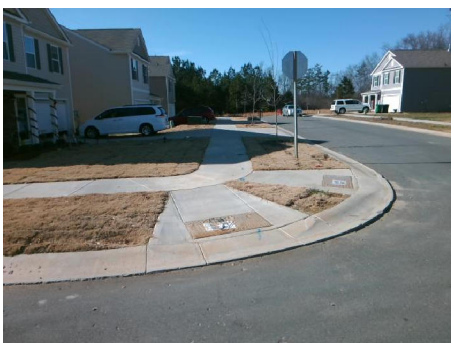
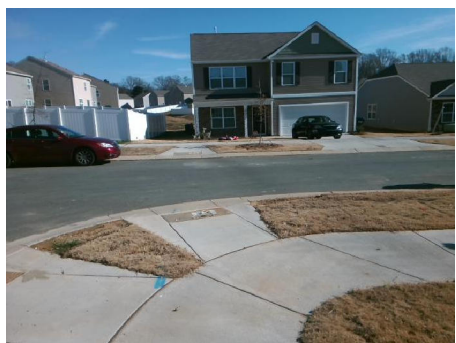
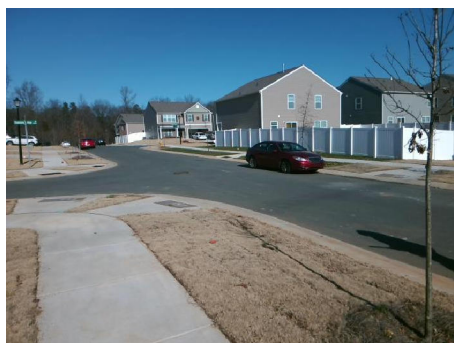
Street 1 Name **MAPLE CREEK CT**
 Stop Condition-Street 2 **None**
 Street 2 Name **N/A**
 Stop Condition-Street 1 **N/A**
