# Access Compliance Report

## Public Rights-of-Way

### (Curb Ramps)

Intersection ID: 12355	Main Street: MONUMENT_ST	Cross Street: GREENLAND_AV	Location: SW
ADA ID: 745434270200	Ramp Type: Perp	Initial Pass/Fail: Fail	Overall Compliance: No
Codes/Mitigation Info/Possible Solution		Field Measurements/Component Compliance	
Severity Score: 10

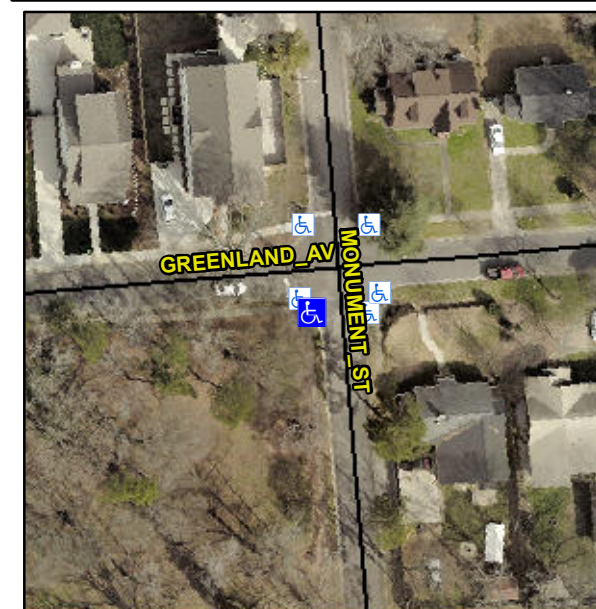
**Not Found, R304.5.1, R304.5.3**

Compliance	Description	Data	Compliance	Description	Data
N/A	Ramp Length (in)	93.0	Yes	Ramp Slope (%)	5.1
No	Ramp Width (in)	46.5	No	Ramp XSlope (%)	2.1
N/A	Flare Type LT	N/A	N/A	Flare Type RT	N/A
N/A	Flare Slope LT (%)	N/A	N/A	Flare Slope RT (%)	N/A
N/A	Flare Traversable LT?	N/A	N/A	Flare Traversable RT?	N/A
N/A	Landing Length (in)	N/A	N/A	DWS Provided?	N/A
N/A	Landing Width (in)	N/A	N/A	DWS Contrast?	N/A
N/A	Landing Slope (%)	N/A	N/A	DWS Length (in)	N/A
N/A	Landing X Slope (%)	N/A	N/A	DWS Full Width?	N/A
N/A	Landing Curb? (Y/N)	N/A	N/A	DWS Offset (in)	N/A
N/A	Shared Landing?	N/A			
N/A	Gutter Ponding?	N/A	N/A	Gutter Slope (%)	N/A
N/A	Gutter Lip Ht (in)	N/A	N/A	Gutter X Slope (%)	N/A
N/A	Painted X Walk1?	No	N/A	Painted X Walk2?	N/A
	X Walk 1 Direction	To E		X Walk 2 Direction	N/A
N/A	X Walk 1 Width (in)	N/A	N/A	X Walk 2 Width (in)	N/A
	X Walk 1 Slope (%)	0.0		X Walk 2 Slope (%)	N/A
	X Walk 1 X Slope (%)	4.0		X Walk 2 X Slope (%)	N/A

N/A	Ramp inside XWalk1?	N/A	N/A	Ramp inside XWalk2?	N/A
	Road Slope (%)	N/A	N/A	Clear Space?	N/A
	Road X Slope (%)	N/A	N/A	Clear Space to XWalk (in)	N/A
N/A	Any Obstructions?	N/A	N/A	Storm Grate/Utility Hazard?	N/A
	Obstruction Type			Storm Grate/Utility Type	
		N/A			N/A
			Yes	Surface Condition? (G/P)	Good

**Remove & Replace Entire Ramp.**
