Access Compliance Report

Public Rights-of-Way

(Curb Ramps)

Intersection ID: 5088	Main Street: GLENWATER_DR	Cross Street: MOUNTAINWATER_DR	Location:	N
ADA ID: 74546653ECF9	Ramp Type: BlendTrans2	Initial Pass/Fail: Pass	Overall Compliance: No	Severity Score: 17.5

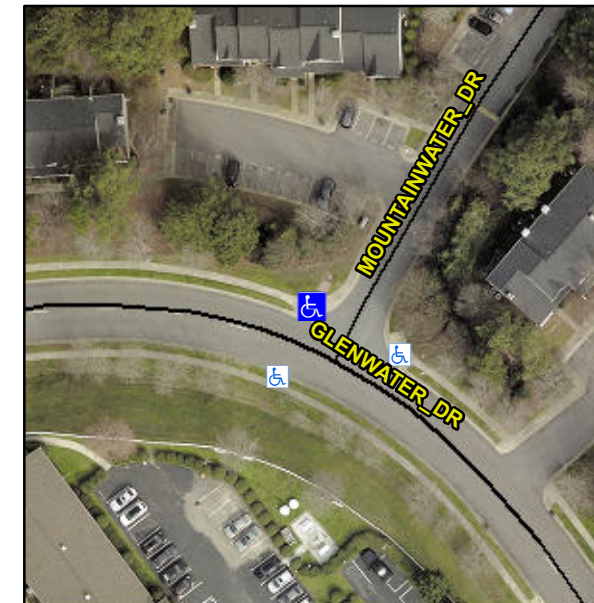
Not Found, R305, R302.7.2

Compliance	Description	Data	Compliance	Description	Data
N/A	Ramp Length (in)	97.0	Yes	BlendTrans Slope (%)	3.8
Yes	Ramp Width (in)	54.5	Yes	BlendTrans XSlope (%)	0.2
N/A	Flare Type LT	Sloped	N/A	Flare Type RT	Sloped
Yes	Flare Slope LT (%)	5.4	Yes	Flare Slope RT (%)	5.1
N/A	Flare Traversable LT?	Yes	N/A	Flare Traversable RT?	Yes
N/A	Landing Length (in)	N/A	No	DWS Provided?	No
N/A	Landing Width (in)	N/A	N/A	DWS Contrast?	No
N/A	Landing Slope (%)	N/A	N/A	DWS Length (in)	N/A
N/A	Landing X Slope (%)	N/A	N/A	DWS Full Width?	No
N/A	Landing Curb? (Y/N)	No	N/A	DWS Offset (in)	N/A
N/A	Shared Landing?	No			
Yes	Gutter Ponding?	No	Yes	Gutter Slope (%)	2.6
No	Gutter Lip Ht (in)	0.5	Yes	Gutter X Slope (%)	2.0
N/A	Painted X Walk1?	No	N/A	Painted X Walk2?	No
	X Walk 1 Direction	To SW		X Walk 2 Direction	To SE
	X Walk 1 Width (in)	N/A		X Walk 2 Width (in)	N/A
	X Walk 1 Slope (%)	4.6		X Walk 2 Slope (%)	2.1
	X Walk 1 X Slope (%)	2.3		X Walk 2 X Slope (%)	7.1

N/A	Ramp inside XWalk1?	N/A	N/A	Ramp inside XWalk2?	N/A
	Road Slope (%)	0.8		Clear Space?	Yes
	Road X Slope (%)	5.6	N/A	Clear Space to XWalk (in)	N/A
Yes	Any Obstructions?	No	Yes	Storm Grate/Utility Hazard?	No
	Obstruction Type			Storm Grate/Utility Type	
		N/A			N/A
			Yes	Surface Condition? (G/P)	Good
			No	Curb Slope (%)	15.9

Remove & Replace Curb Ramp With Two New Directional Ramps or Equivalent.

Total Cost: \$ 3200.00
