Access Compliance Report

Public Rights-of-Way

(Curb Ramps)

Intersection ID: 28174	Main Street: BLAKENEY_HEATH_RD	Cross Street: FIELDCROFT_DR	Location: SW
ADA ID: 745A850474E7	Ramp Type: Perp	Initial Pass/Fail: Fail	Overall Compliance: No
Codes/Mitigation Info/Possible Solution			Severity Score: 10
			Field Measurements/Component Compliance

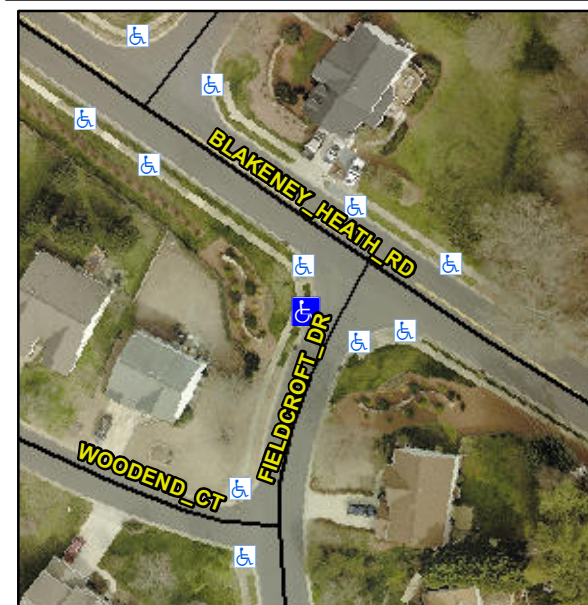
Compliance	Description	Data	Compliance	Description	Data
N/A	Ramp Length (in)	96.0	Yes	Ramp Slope (%)	6.9
No	Ramp Width (in)	45.0	No	Ramp XSlope (%)	3.4
N/A	Flare Type LT	N/A	N/A	Flare Type RT	N/A
N/A	Flare Slope LT (%)	N/A	N/A	Flare Slope RT (%)	N/A
N/A	Flare Traversable LT?	N/A	N/A	Flare Traversable RT?	N/A
N/A	Landing Length (in)	N/A	N/A	DWS Provided?	N/A
N/A	Landing Width (in)	N/A	N/A	DWS Contrast?	N/A
N/A	Landing Slope (%)	N/A	N/A	DWS Length (in)	N/A
N/A	Landing X Slope (%)	N/A	N/A	DWS Full Width?	N/A
N/A	Landing Curb? (Y/N)	N/A	N/A	DWS Offset (in)	N/A
N/A	Shared Landing?	N/A			
N/A	Gutter Ponding?	N/A	N/A	Gutter Slope (%)	N/A
N/A	Gutter Lip Ht (in)	N/A	N/A	Gutter X Slope (%)	N/A
N/A	Painted X Walk1?	No	N/A	Painted X Walk2?	N/A
	X Walk 1 Direction	To SE		X Walk 2 Direction	N/A
N/A	X Walk 1 Width (in)	N/A	N/A	X Walk 2 Width (in)	N/A
	X Walk 1 Slope (%)	1.3		X Walk 2 Slope (%)	N/A
	X Walk 1 X Slope (%)	3.2		X Walk 2 X Slope (%)	N/A

N/A	Ramp inside XWalk1?	N/A	N/A	Ramp inside XWalk2?	N/A
	Road Slope (%)	N/A	N/A	Clear Space?	N/A
	Road X Slope (%)	N/A	N/A	Clear Space to XWalk (in)	N/A
N/A	Any Obstructions?	N/A	N/A	Storm Grate/Utility Hazard?	N/A
	Obstruction Type			Storm Grate/Utility Type	
		N/A			N/A
			Yes	Surface Condition? (G/P)	Good

Possible Solutions:

Remove & Replace Entire Ramp.
