Access Compliance Report Public Rights-of-Way (Curb Ramps)

Intersection ID: 10025452 Main Street: E_INDEPENDENCE_BV Cross Street: N/A Location: NW

ADA ID: 745D704A8E77 Ramp Type: Directional1 Initial Pass/Fail: Pass Overall Compliance: No Severity Score: 5

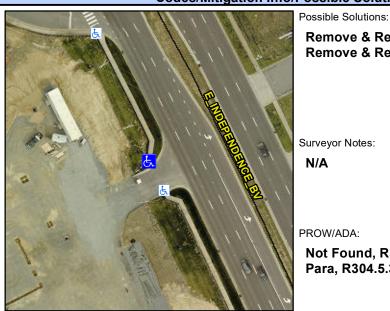
PROW/ADA:
Not Found, R304.2.2-Perp, R304.3.2-Para, R304.5.3, R304.5.4

Field Measurements/Component Compliance					
Compl	iance Description	Data	Comp	liance Description	Data
N/A	Ramp Length (in)	31.0	Yes	Grade Break?	Yes
Yes	Ramp Width (in)	60.0	No	Grade Break Slope (%)	9.1
Yes	Ramp Slope (%)	6.6	Yes	Grade Break XSlope (%)	0.7
Yes	Ramp XSlope (%)	2.0			
N/A	Flare Type LT	N/A	N/A	Flare Type RT	N/A
N/A	Flare Slope LT (%)	N/A	N/A	Flare Slope RT (%)	N/A
N/A	Flare Traversable LT?	N/A	N/A	Flare Traversable RT?	N/A
Yes	Landing Length (in)	65.0	Yes	DWS Provided?	Yes
Yes	Landing Width (in)	60.0	Yes	DWS Contrast?	Yes
No	Landing Slope (%)	2.1	Yes	DWS Length (in)	24.0
Yes	Landing X Slope (%)	1.4	Yes	DWS Full Width?	Yes
N/A	Landing Curb? (Y/N)	N/A	Yes	DWS Offset LT (in)	23.0
N/A	Shared Landing?	No	Yes	DWS Offset RT (in)	0.0
Yes	Gutter Ponding?	No	No	Gutter Slope (%)	5.7
Yes	Gutter Lip Ht (in)	0.0	Yes	Gutter X Slope (%)	2.1
N/A	Painted X Walk1?	No		Road Slope (%)	0.8
	X Walk 1 Direction	To SE		Road X Slope (%)	2.6

X Walk 1 Width (in)	N/A		Clear Space?	Yes
	X Walk 1 Slope (%)	0.8	N/A	Clear Space to XWalk (in)	N/A
	X Walk 1 X Slope (%)	2.6	Yes	Storm Grate/Utility Hazard?	No
N/A	Ramp inside XWalk1?	N/A		Storm Grate/Utility Type	
Yes	Any Obstructions?	No			N/A
	Obstruction Type		Yes	Surface Condition? (G/P)	Good
		N/A	No	Curb Slope (%)	11.7

Remove & Replace Entire Ramp.
Remove & Replace Gutter.
